[BNES Keynsham bypass Report 11367-2016.pdf](#)

North Somerset Council Highway Services Laboratory

REPORT No: 11/03-BCC-Wells Road Bristol-

**TEST : Visual Examination of Cores and Each layer chemically tested for Tar presence and those identified further tested for Waste Acceptance Criteria Certification**

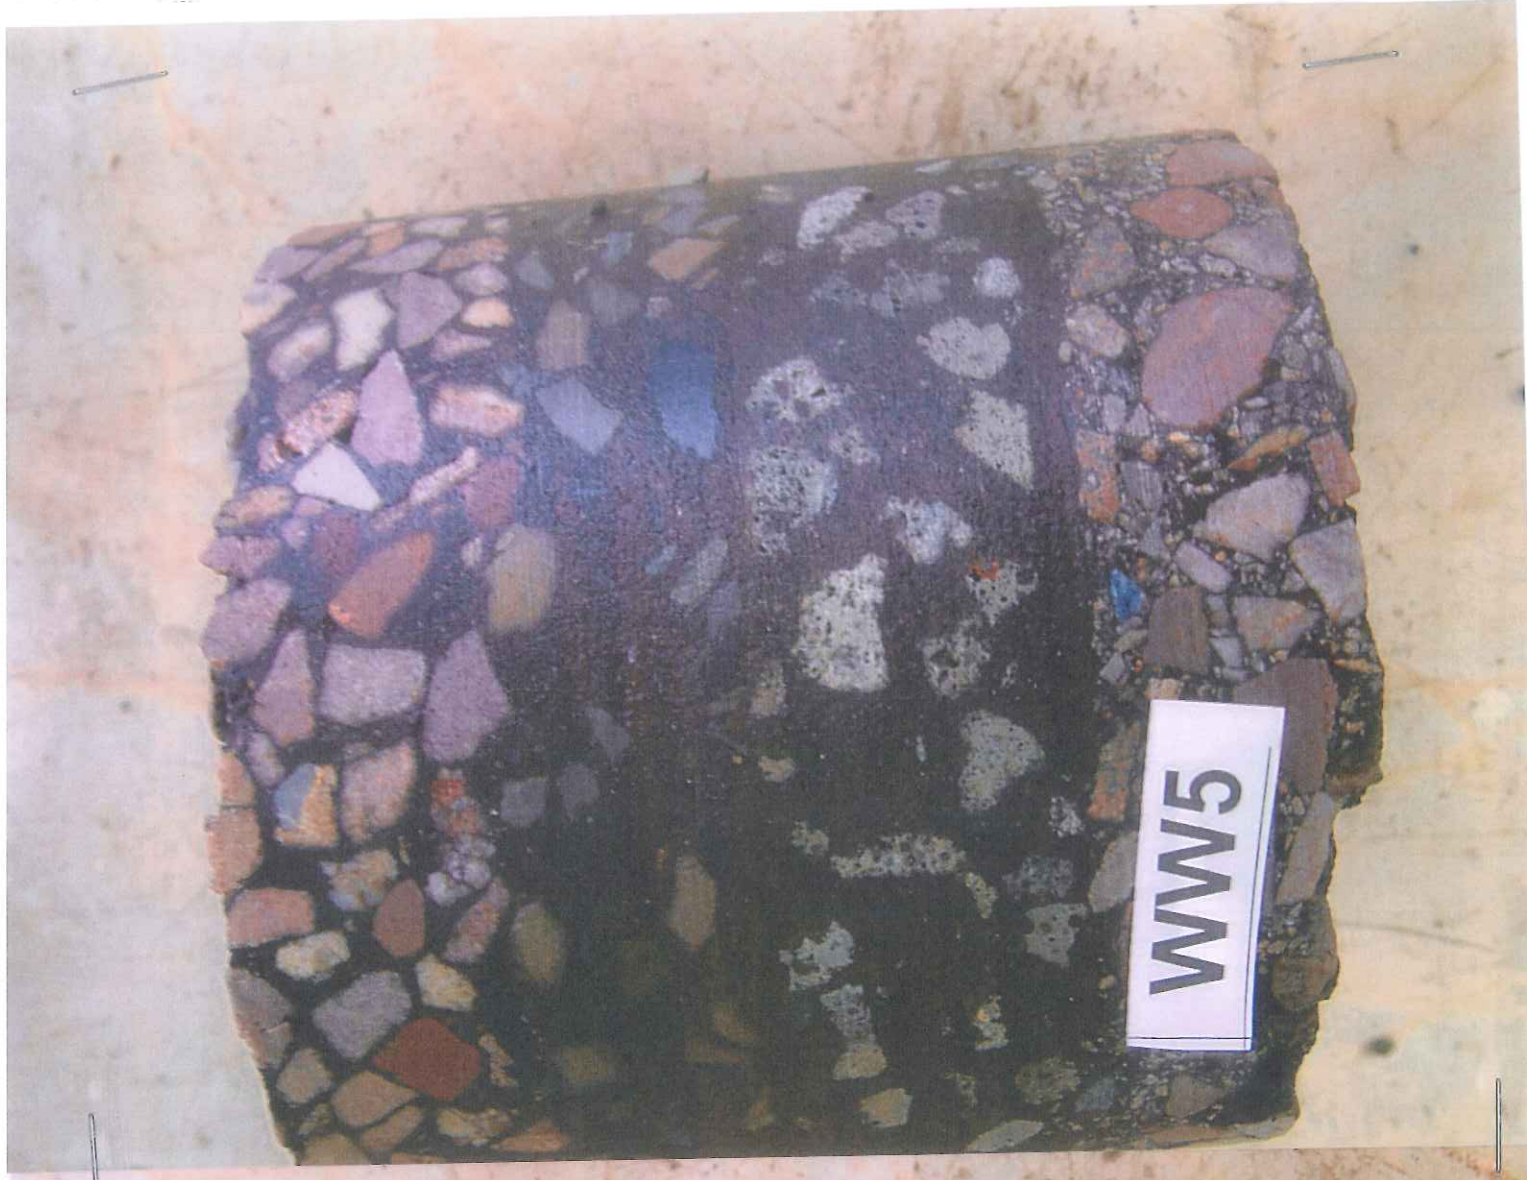
WW5

Core No (WW5 ) = 135mm Tar indicated below 105mm

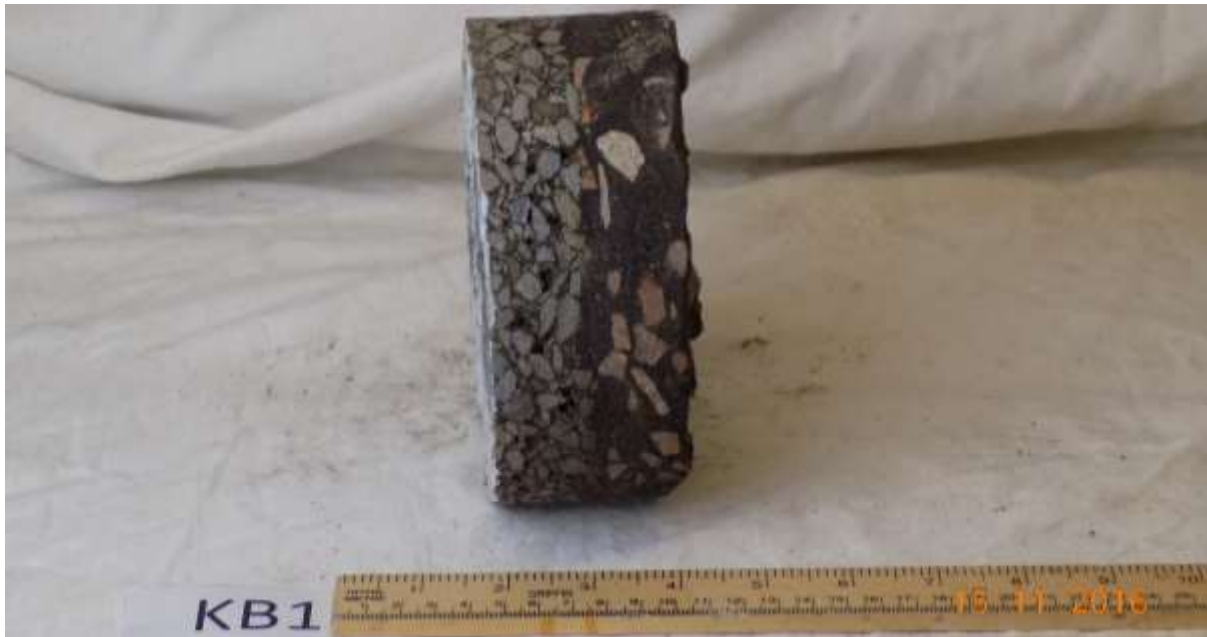
**Plate 2:** Core reference: KB1

<b>Core Reference:</b>	KB1
<b>Location</b>	Just before Waitrose exit, Broadmead RAB
<b>Total Depth Core (mm)</b>	64
<b>Surface Course Type</b>	10mm SMA <sup>1</sup>
<b>Aggregate Type &amp; PSV</b>	Gritstone 60
<b>Thickness Found (mm)</b>	30
<b>1) Bound Material Type</b>	14mm 35% HRA
<b>Thickness Found (mm)</b>	34
<b>Foundation Material</b>	Granular subbase
<b>Significant Quantity Lifted</b>	No
<b>WAC Potentially Required</b>	No

**Remarks:** Based on the pattern of cracking in the wearing course and comparison to the other cores on the roundabout this core appears to have been taken on a trench which has since been overlaid.

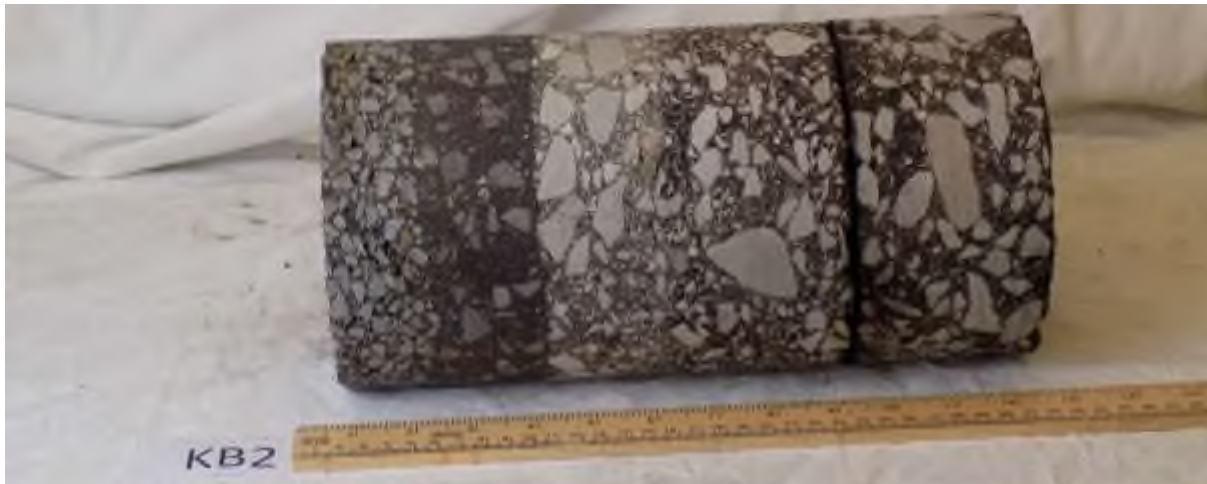
**Plate 3:** Core reference: KB2**Table 3:** Visual examination results and WAC recommendations for core ref: KB2

<b>Core Reference:</b>	KB2
<b>Location</b>	Just before Bath/Saltford Exit, Broadmead RAB
<b>Total Depth Core (mm)</b>	294
<b>Surface Course Type</b>	10mm SMA <sup>1</sup>
<b>Aggregate Type &amp; PSV</b>	Gritstone 60
<b>Thickness Found (mm)</b>	41
<b>1) Bound Material Type</b>	14mm 35% HRA
<b>Thickness Found (mm)</b>	47
<b>2) Bound Material Type</b>	20mm A/C
<b>Thickness Found (mm)</b>	48
<b>3) Bound Material Type</b>	32mm A/C <sup>7</sup>
<b>Thickness Found (mm)</b>	76
<b>4) Bound Material Type</b>	32mm A/C
<b>Thickness Found (mm)</b>	82
<b>Foundation Material</b>	Granular subbase
<b>Significant Quantity Lifted</b>	No
<b>WAC Potentially Required</b>	Yes

**Remarks:** Tar present in some 32mm A/C

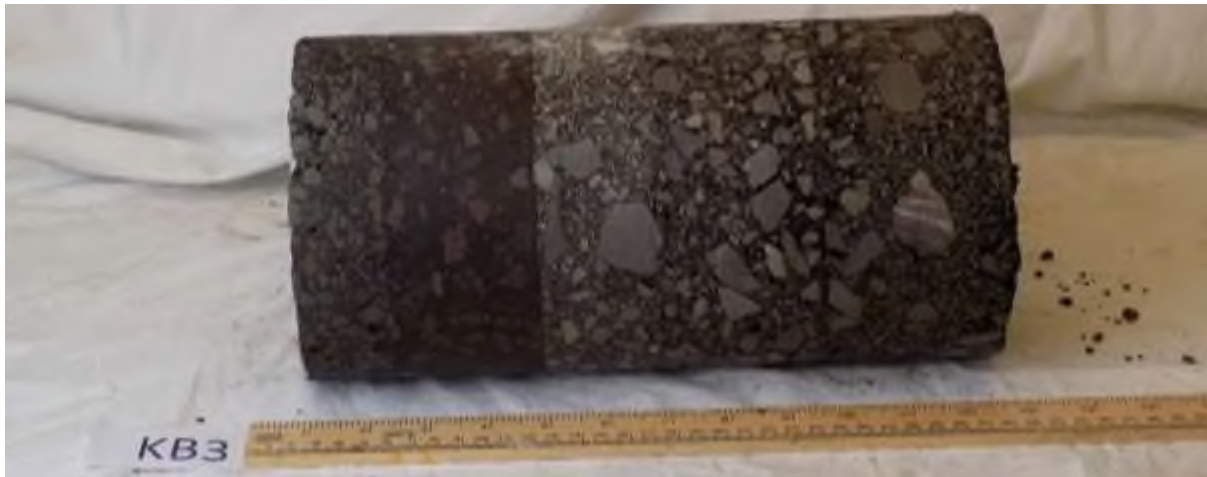
**Plate 4:** Core reference: KB3

<b>Core Reference:</b>	KB3
<b>Location</b>	Just after Bath/Saltford Exit, Broadmead RAB
<b>Total Depth Core (mm)</b>	304
<b>Surface Course Type</b>	10mm SMA <sup>1</sup>
<b>Aggregate Type &amp; PSV</b>	Gritstone 60
<b>Thickness Found (mm)</b>	42
<b>1) Bound Material Type</b>	14mm 35% HRA
<b>Thickness Found (mm)</b>	62
<b>2) Bound Material Type</b>	20mm A/C
<b>Thickness Found (mm)</b>	50
<b>3) Bound Material Type</b>	32mm A/C
<b>Thickness Found (mm)</b>	70
<b>4) Bound Material Type</b>	32mm A/C
<b>Thickness Found (mm)</b>	80
<b>Foundation Material</b>	Granular subbase
<b>Significant Quantity Lifted</b>	No
<b>WAC Potentially Required</b>	Yes

**Remarks:** Tar present in some 32mm A/C

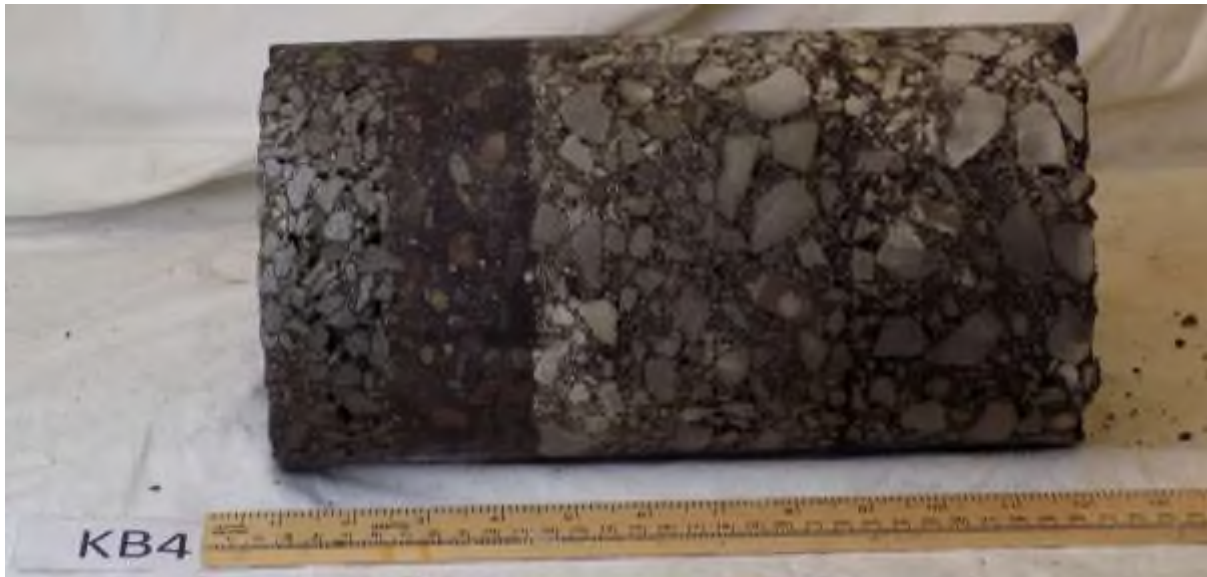
**Plate 5:** Core reference: KB4**Table 5:** Visual examination results and WAC recommendations: KB4

<b>Core Reference:</b>	KB4
<b>Location</b>	Near exit for school, Broadmead RAB
<b>Total Depth Core (mm)</b>	280
<b>Surface Course Type</b>	10mm SMA <sup>1</sup>
<b>Aggregate Type &amp; PSV</b>	Gritstone 60
<b>Thickness Found (mm)</b>	46
<b>1) Bound Material Type</b>	14mm 35% HRA
<b>Thickness Found (mm)</b>	46
<b>2) Bound Material Type</b>	20mm A/C
<b>Thickness Found (mm)</b>	30
<b>3) Bound Material Type</b>	32mm A/C <sup>1</sup>
<b>Thickness Found (mm)</b>	78
<b>4) Bound Material Type</b>	32mm A/C
<b>Thickness Found (mm)</b>	80
<b>Foundation Material</b>	Granular subbase
<b>Significant Quantity Lifted</b>	No
<b>WAC Potentially Required</b>	Yes

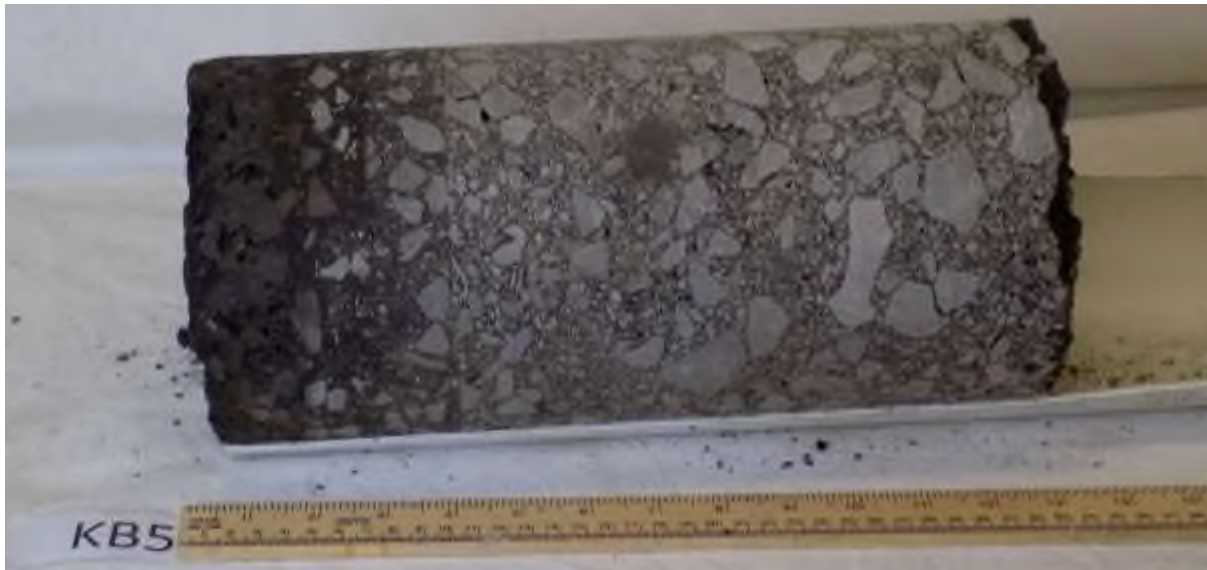
**Plate 6:** Core reference: KB5**Table 6:** Visual examination results and WAC recommendations for core ref: KB5

<b>Core Reference:</b>	KB5
<b>Location</b>	Lane1, westbound
<b>Total Depth Core (mm)</b>	318
<b>Surface Course Type</b>	14mm SMA <sup>1</sup>
<b>Aggregate Type &amp; PSV</b>	Gritstone 60
<b>Thickness Found (mm)</b>	35
<b>1) Bound Material Type</b>	14mm 35% HRA
<b>Thickness Found (mm)</b>	33
<b>2) Bound Material Type</b>	14mm 35% HRA
<b>Thickness Found (mm)</b>	29
<b>3) Bound Material Type</b>	20mm A/C
<b>Thickness Found (mm)</b>	39
<b>4) Bound Material Type</b>	32mm A/C
<b>Thickness Found (mm)</b>	88
<b>5) Bound Material Type</b>	32mm A/C
<b>Thickness Found (mm)</b>	94
<b>Foundation Material</b>	Granular subbase
<b>Significant Quantity Lifted</b>	No
<b>WAC Potentially Required</b>	Yes

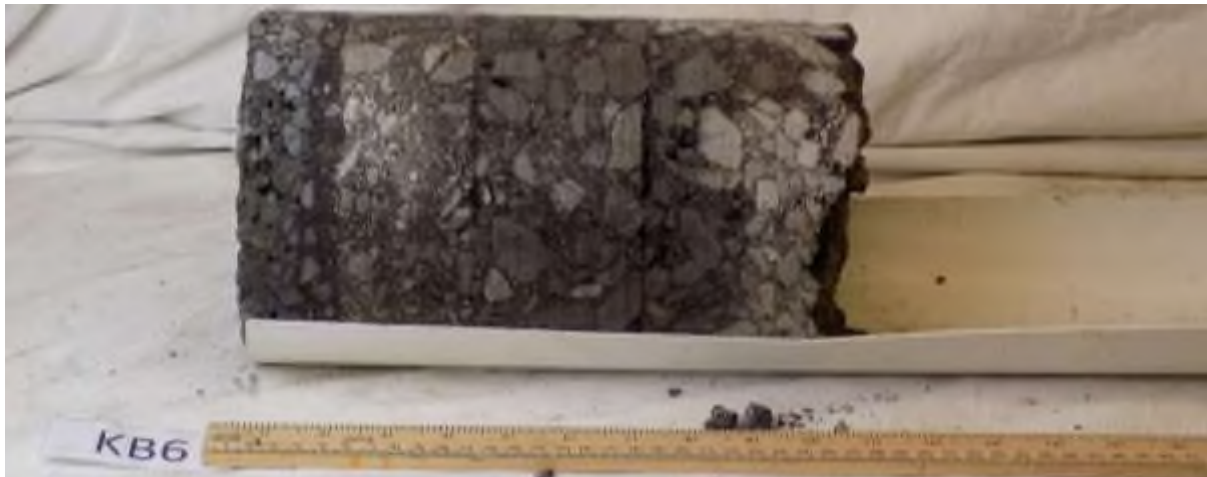
**Plate 7:** Core reference: KB6**Table 7:** Visual examination results and WAC recommendations for core ref: KB6

<b>Core Reference:</b>	KB6
<b>Location</b>	Lane 2, Westbound
<b>Total Depth Core (mm)</b>	253
<b>Surface Course Type</b>	14mm SMA <sup>1</sup>
<b>Aggregate Type &amp; PSV</b>	Gritstone 60
<b>Thickness Found (mm)</b>	28
<b>1) Bound Material Type</b>	14mm 35% HRA
<b>Thickness Found (mm)</b>	12
<b>2) Bound Material Type</b>	20mm A/C
<b>Thickness Found (mm)</b>	55
<b>3) Bound Material Type</b>	32mm A/C
<b>Thickness Found (mm)</b>	68
<b>4) Bound Material Type</b>	32mm A/C
<b>Thickness Found (mm)</b>	90
<b>Foundation Material</b>	Granular subbase
<b>Significant Quantity Lifted</b>	No
<b>WAC Potentially Required</b>	Yes

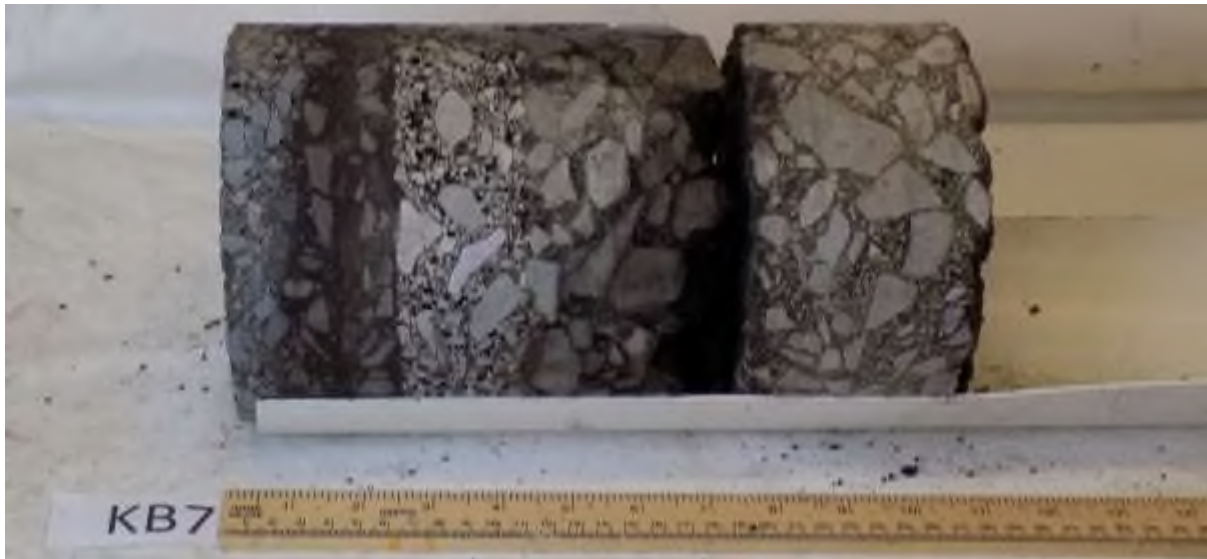
**Plate 8:** Core reference: KB7**Table 8:** Visual examination results and WAC recommendations for core ref: KB7

<b>Core Reference:</b>	KB7
<b>Location</b>	Lane 1, Westbound
<b>Total Depth Core (mm)</b>	267
<b>Surface Course Type</b>	14mm SMA <sup>1</sup>
<b>Aggregate Type &amp; PSV</b>	Gritstone 60
<b>Thickness Found (mm)</b>	26
<b>1) Bound Material Type</b>	14mm 35% HRA
<b>Thickness Found (mm)</b>	36
<b>2) Bound Material Type</b>	20mm A/C
<b>Thickness Found (mm)</b>	45
<b>3) Bound Material Type</b>	32mm A/C <sup>3,7</sup>
<b>Thickness Found (mm)</b>	75
<b>4) Bound Material Type</b>	32mm A/C
<b>Thickness Found (mm)</b>	85
<b>Foundation Material</b>	Granular subbase
<b>Significant Quantity Lifted</b>	No
<b>WAC Potentially Required</b>	Yes

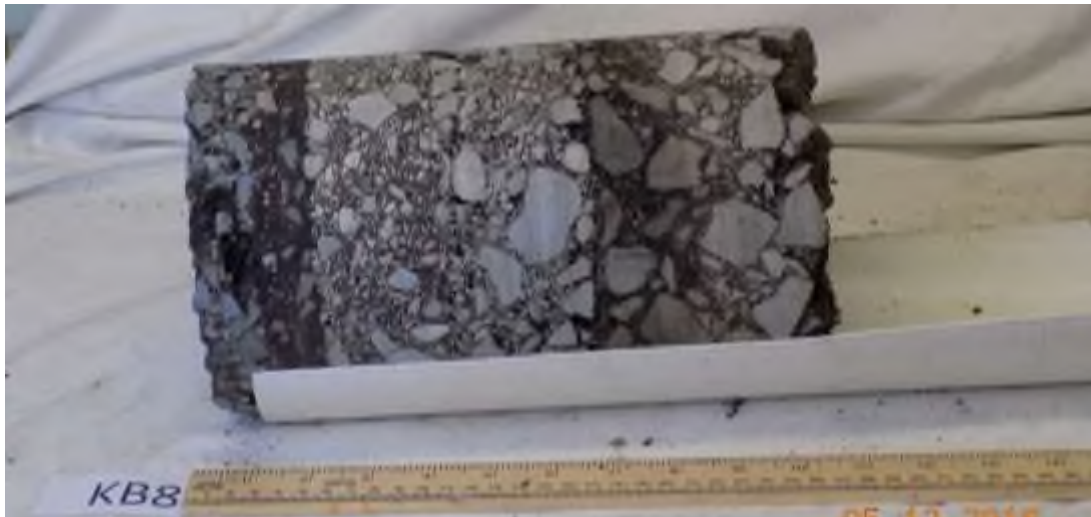
**Plate 9:** Core reference: KB8**Table 9:** Visual examination results and WAC recommendations for core ref: KB8

<b>Core Reference:</b>	KB8
<b>Location</b>	Lane 2, westbound
<b>Total Depth Core (mm)</b>	254
<b>Surface Course Type</b>	14mm SMA <sup>1</sup>
<b>Aggregate Type &amp; PSV</b>	Gritstone 60
<b>Thickness Found (mm)</b>	25
<b>1) Bound Material Type</b>	14mm 35% HRA
<b>Thickness Found (mm)</b>	23
<b>2) Bound Material Type</b>	20mm A/C
<b>Thickness Found (mm)</b>	51
<b>3) Bound Material Type</b>	32mm A/C
<b>Thickness Found (mm)</b>	60
<b>4) Bound Material Type</b>	32mm A/C
<b>Thickness Found</b>	95
<b>Foundation Material</b>	Granular subbase
<b>Significant Quantity Lifted</b>	No
<b>WAC Potentially Required</b>	Yes

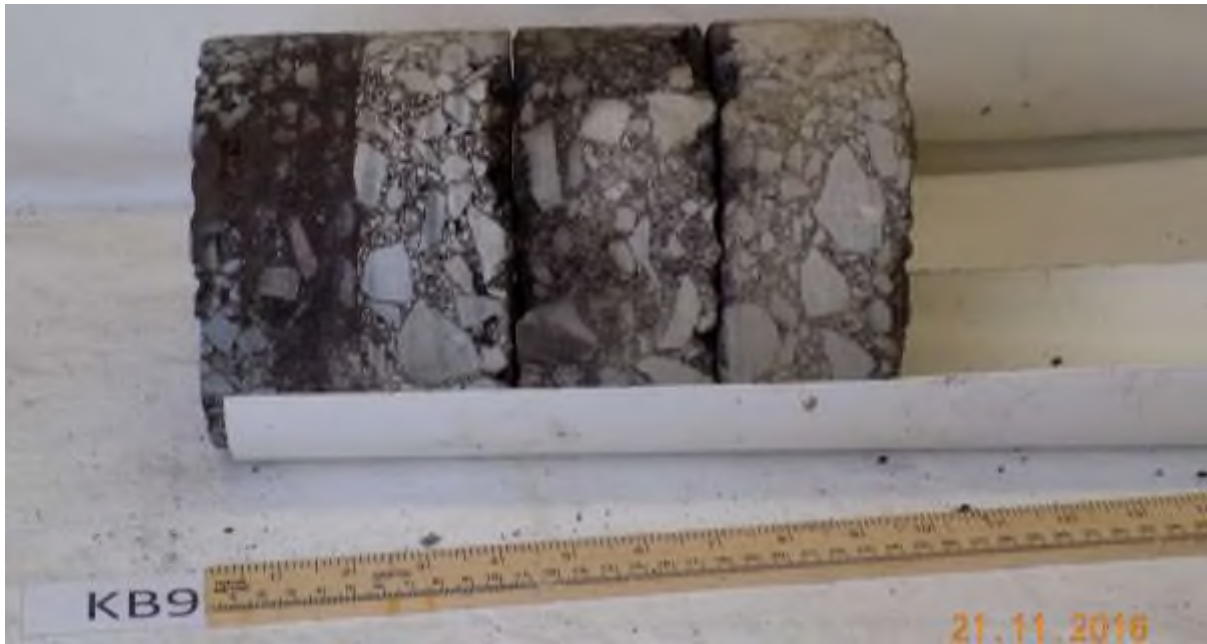
**Plate 10:** Core reference: KB9**Table 10:** Visual examination results and WAC recommendations for core ref: KB9

<b>Core Reference:</b>	KB9
<b>Location</b>	Lane 2, westbound
<b>Total Depth Core (mm)</b>	238
<b>Surface Course Type</b>	14mm SMA`
<b>Aggregate Type &amp; PSV</b>	Gritstone 60
<b>Thickness Found (mm)</b>	28
<b>1) Bound Material Type</b>	14mm 35% HRA
<b>Thickness Found (mm)</b>	16
<b>2) Bound Material Type</b>	14mm 35% HRA
<b>Thickness Found (mm)</b>	15
<b>3) Bound Materials Type</b>	20mm A/C <sup>7</sup>
<b>Thickness Found (mm)</b>	48
<b>4) Bound Material Type</b>	32mm A/C <sup>7</sup>
<b>Thickness Found (mm)</b>	66
<b>5) Bound Material Type</b>	32mm A/C
<b>Thickness Found (mm)</b>	65
<b>Foundation Material</b>	Granular subbase
<b>Significant Quantity Lifted</b>	No
<b>WAC Potentially Required</b>	Yes

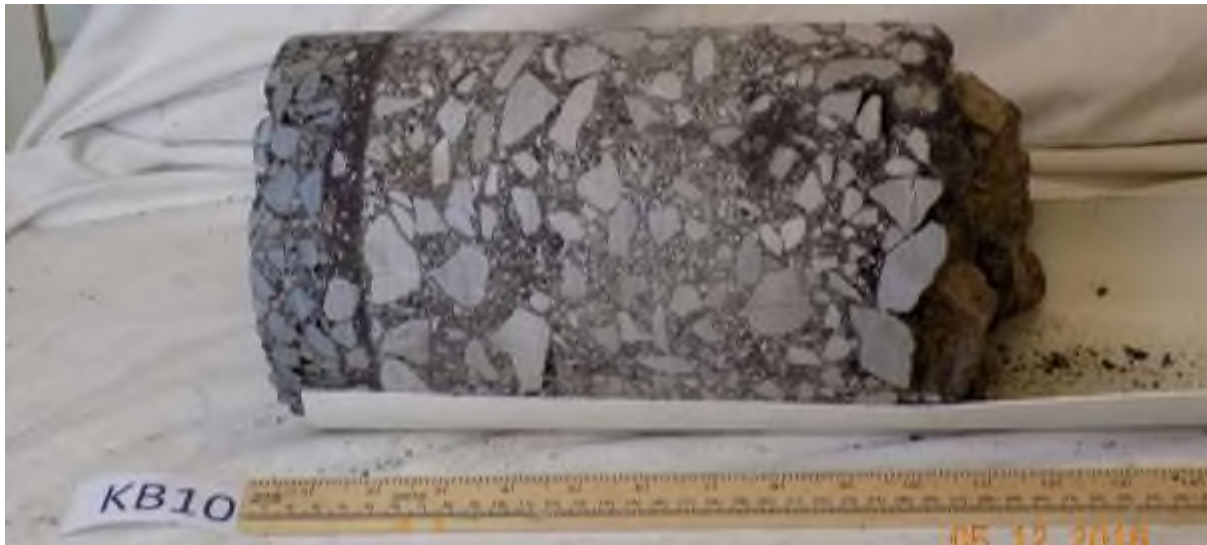
**Plate 11:** Core reference: KB10**Table 11:** Visual examination results and WAC recommendations for core ref: KB10

<b>Core Reference:</b>	KB10
<b>Location</b>	Lane 2, westbound
<b>Total Depth Core (mm)</b>	273
<b>Surface Course Type</b>	14mm SMA <sup>1</sup>
<b>Aggregate Type &amp; PSV</b>	Gritstone 60
<b>Thickness Found (mm)</b>	29
<b>1) Bound Material Type</b>	14mm 35% HRA
<b>Thickness Found (mm)</b>	14
<b>2) Bound Material Type</b>	32mm A/C
<b>Thickness Found (mm)</b>	65
<b>3) Bound Material Type</b>	32mm A/C
<b>Thickness Found (mm)</b>	75
<b>4) Bound Material Type</b>	32mm A/C <sup>1</sup>
<b>Thickness Found (mm)</b>	90
<b>Foundation Material</b>	Granular subbase
<b>Significant Quantity Lifted</b>	No

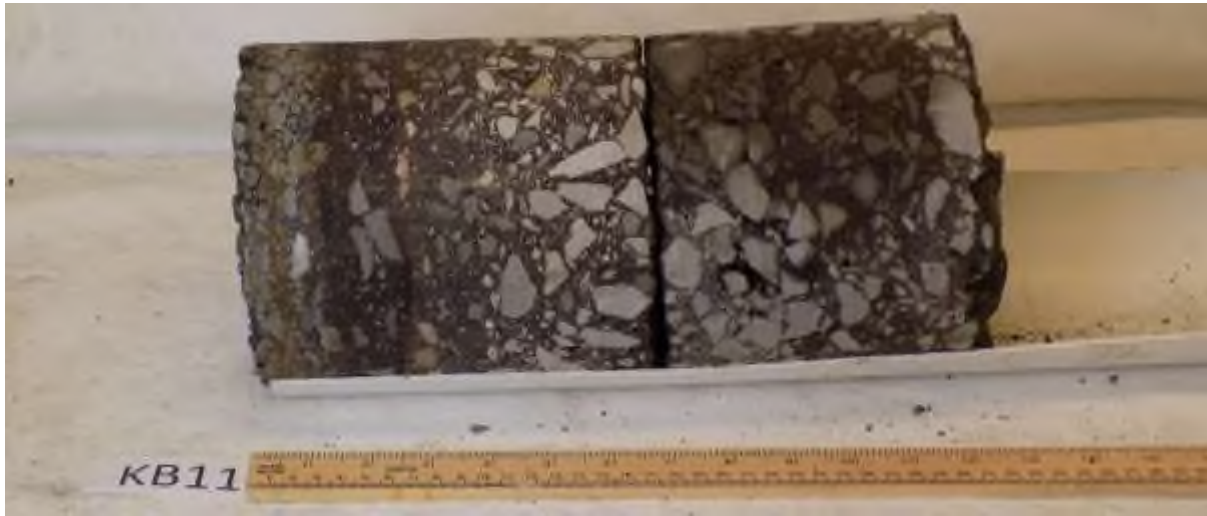
**Plate 12:** Core reference: KB11**Table 12:** Visual examination results and WAC recommendations for core ref: KB11

<b>Core Reference:</b>	KB11
<b>Location</b>	Lane 1, westbound
<b>Total Depth Core (mm)</b>	307
<b>Surface Course Type</b>	14mm SMA <sup>1</sup>
<b>Aggregate Type &amp; PSV</b>	Gritstone 60
<b>Thickness Found (mm)</b>	28
<b>1) Bound Material Type</b>	14mm 35% HRA
<b>Thickness Found (mm)</b>	41
<b>2) Bound Material Type</b>	14mm 35% HRA
<b>Thickness Found (mm)</b>	32
<b>3) Bound Material Type</b>	20mm A/C <sup>7</sup>
<b>Thickness Found (mm)</b>	72
<b>4) Bound Material Type</b>	20mm A/C <sup>1</sup>
<b>Thickness Found</b>	47
<b>5) Bound Material Type</b>	32mm A/C
<b>Thickness Found</b>	87
<b>Foundation Material</b>	Granular subbase
<b>Significant Quantity Lifted</b>	No
<b>WAC Potentially Required</b>	Yes

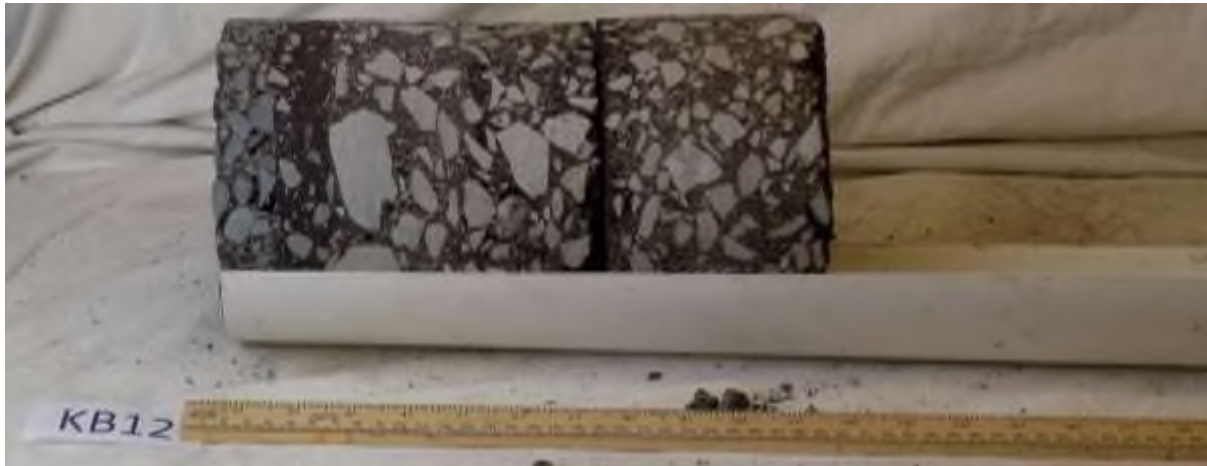
**Plate 13:** Core reference: KB12**Table 13:** Visual examination results and WAC recommendations for core ref: KB12

<b>Core Reference:</b>	KB12
<b>Location</b>	Lane 2, westbound
<b>Total Depth Core (mm)</b>	283
<b>Surface Course Type</b>	14mm SMA
<b>Aggregate Type &amp; PSV</b>	Gritstone 60
<b>Thickness Found (mm)</b>	25
<b>1) Bound Material Type</b>	14mm 35% HRA
<b>Thickness Found (mm)</b>	28
<b>2) Bound Material Type</b>	32mm A/C
<b>Thickness Found (mm)</b>	60
<b>3) Bound Material Type</b>	32mm A/C
<b>Thickness Found (mm)</b>	65
<b>4) Bound Material Type</b>	20mm A/C
<b>Thickness Found (mm)</b>	105
<b>Foundation Material</b>	Granular subbase
<b>Significant Quantity Lifted</b>	No
<b>WAC Potentially Required</b>	Yes

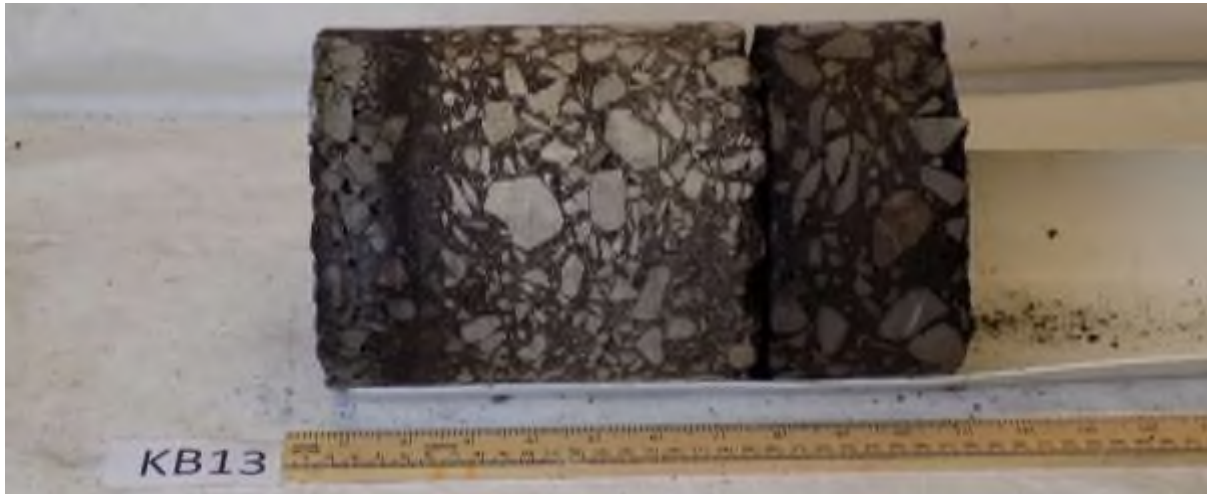
**Plate 14:** Core reference: KB13**Table 14:** Visual examination results and WAC recommendations for core ref: KB13

<b>Core Reference:</b>	KB13
<b>Location</b>	Lane 1, westbound
<b>Total Depth Core (mm)</b>	254
<b>Surface Course Type</b>	14mm SMA <sup>1</sup>
<b>Aggregate Type &amp; PSV</b>	Gritstone 60
<b>Thickness Found (mm)</b>	31
<b>1) Bound Material Type</b>	14mm 35% HRA
<b>Thickness Found (mm)</b>	20
<b>2) Bound Material Type</b>	20mm A/C
<b>Thickness Found (mm)</b>	56
<b>3) Bound Material Type</b>	32mm A/C <sup>7</sup>
<b>Thickness Found</b>	70
<b>4) Bound Material Type</b>	32mm A/C
<b>Thickness Found (mm)</b>	77
<b>Foundation Material</b>	Granular subbase
<b>Significant Quantity Lifted</b>	No
<b>WAC Potentially Required</b>	Yes

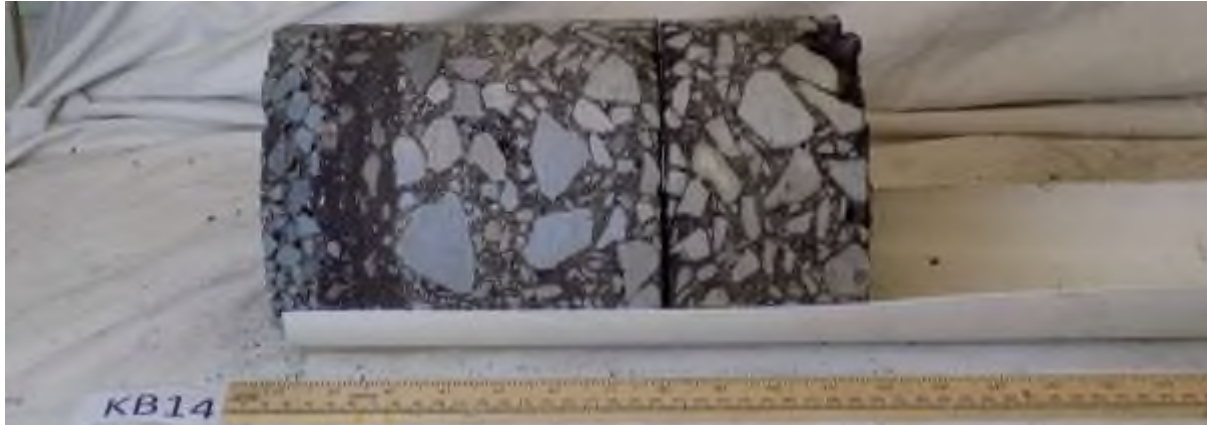
**Plate 15:** Core reference: KB14**Table 15:** Visual examination results and WAC recommendations for core ref: KB14

<b>Core Reference:</b>	KB14
<b>Location</b>	Lane 2, westbound
<b>Total Depth Core (mm)</b>	256
<b>Surface Course Type</b>	14mm SMA <sup>1</sup>
<b>Aggregate Type &amp; PSV</b>	Gritstone 60
<b>Thickness Found (mm)</b>	25
<b>1) Bound Material Type</b>	14mm 35% HRA
<b>Thickness Found (mm)</b>	31
<b>2) Bound Material Type</b>	32mm A/C*
<b>Thickness Found (mm)</b>	50
<b>3) Bound Material Type</b>	32mm A/C <sup>7</sup>
<b>Thickness Found</b>	63
<b>4) Bound Material Type</b>	32mm A/C
<b>Thickness Found (mm)</b>	87
<b>Foundation Material</b>	Granular subbase
<b>Significant Quantity Lifted</b>	No
<b>WAC Potentially Required</b>	Yes

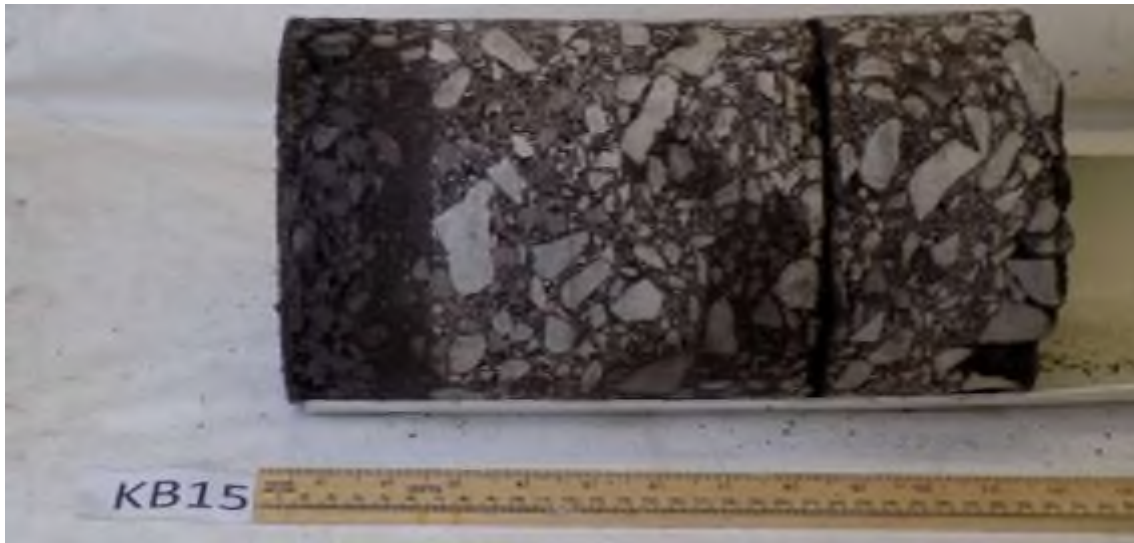
**Plate 16:** Core reference: KB15**Table 16:** Visual examination results and WAC recommendations for core ref: KB15

<b>Core Reference:</b>	KB15
<b>Location</b>	Lane 1, westbound
<b>Total Depth Core (mm)</b>	287
<b>Surface Course Type</b>	14mm SMA <sup>1</sup>
<b>Aggregate Type &amp; PSV</b>	Gritstone 60
<b>Thickness Found (mm)</b>	32
<b>1) Bound Material Type</b>	14mm 35% HRA
<b>Thickness Found (mm)</b>	26
<b>2) Bound Material Type</b>	20mm A/C
<b>Thickness Found (mm)</b>	65
<b>3) Bound Material Type</b>	32mm A/C <sup>7</sup>
<b>Thickness Found</b>	78
<b>4) Bound Material Type</b>	32mm A/C
<b>Thickness Found (mm)</b>	86
<b>Foundation Material</b>	Granular subbase
<b>Significant Quantity Lifted</b>	No
<b>WAC Potentially Required</b>	Yes

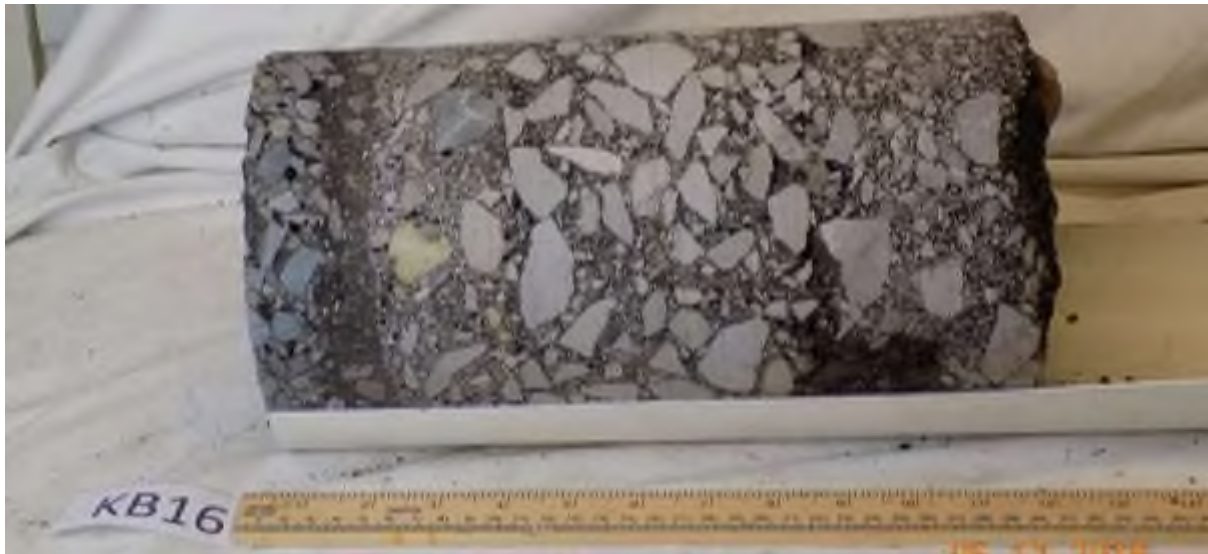
**Plate 17:** Core reference: KB16**Table 17:** Visual examination results and WAC recommendations for core ref: KB16

<b>Core Reference:</b>	KB16
<b>Location</b>	Lane 2, westbound
<b>Total Depth Core (mm)</b>	292
<b>Surface Course Type</b>	14mm SMA <sup>1</sup>
<b>Aggregate Type &amp; PSV</b>	Gritstone 60
<b>Thickness Found (mm)</b>	30
<b>1) Bound Material Type</b>	14mm 35% HRA
<b>Thickness Found (mm)</b>	22
<b>2) Bound Material Type</b>	32mm A/C
<b>Thickness Found (mm)</b>	48
<b>3) Bound Material Type</b>	32mm A/C
<b>Thickness Found</b>	110
<b>4) Bound Material Type</b>	32mm A/C
<b>Thickness Found (mm)</b>	82
<b>Foundation Material</b>	Granular subbase
<b>Significant Quantity Lifted</b>	No
<b>WAC Potentially Required</b>	Yes

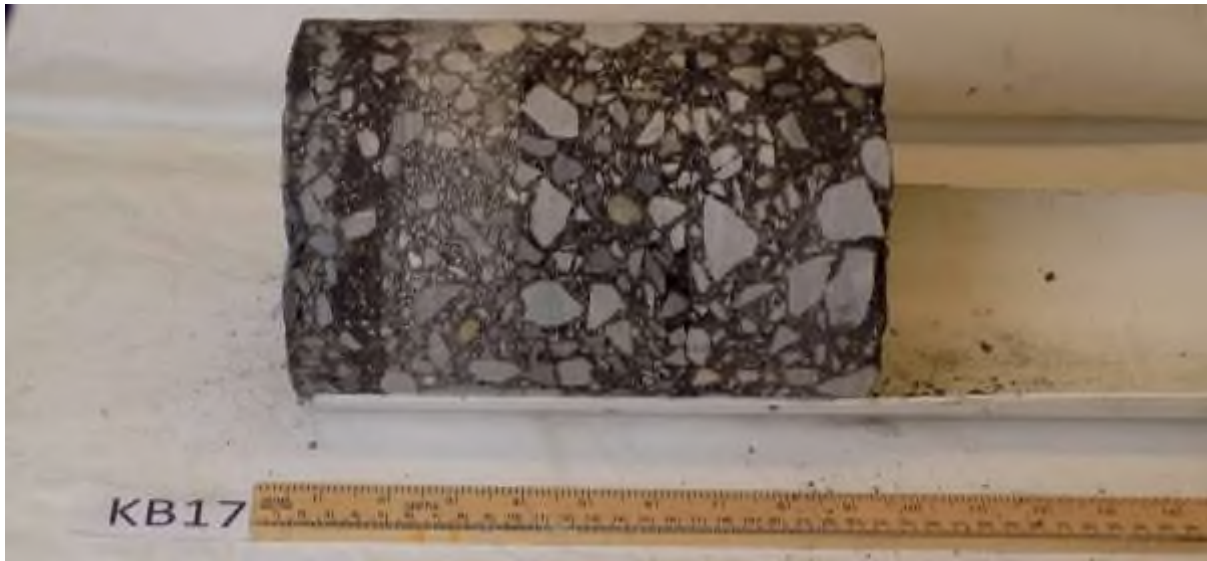
**Plate 18:** Core reference: KB17**Table 18:** Visual examination results and WAC recommendations for core ref: KB17

<b>Core Reference:</b>	KB17
<b>Location</b>	Lane 1, westbound
<b>Total Depth Core (mm)</b>	224
<b>Surface Course Type</b>	14mm SMA <sup>1</sup>
<b>Aggregate Type &amp; PSV</b>	Gritstone 60
<b>Thickness Found (mm)</b>	24
<b>1) Bound Material Type</b>	14mm 35% HRA
<b>Thickness Found (mm)</b>	23
<b>2) Bound Material Type</b>	20mm A/C
<b>Thickness Found (mm)</b>	45
<b>3) Bound Material Type</b>	32mm A/C
<b>Thickness Found</b>	60
<b>4) Bound Material Type</b>	32mm A/C
<b>Thickness Found (mm)</b>	72
<b>Foundation Material</b>	Granular subbase
<b>Significant Quantity Lifted</b>	No
<b>WAC Potentially Required</b>	Yes

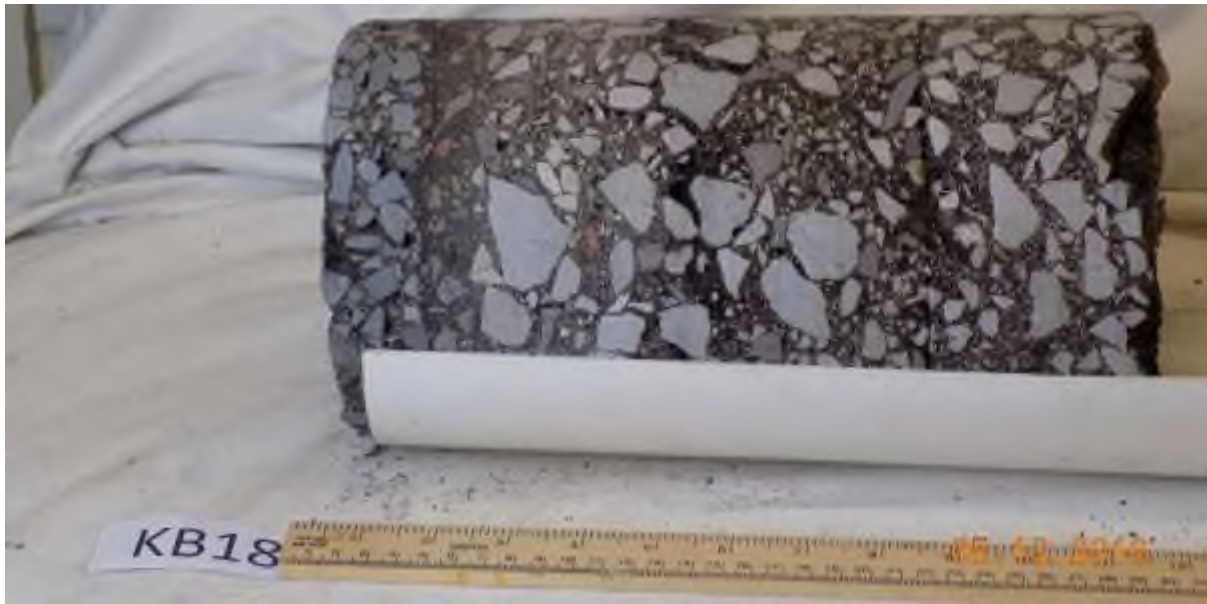
**Plate 19:** Core reference: KB18**Table 19:** Visual examination results and WAC recommendations for core ref: KB18

<b>Core Reference:</b>	KB18
<b>Location</b>	Lane 2, westbound
<b>Total Depth Core (mm)</b>	274
<b>Surface Course Type</b>	14mm SMA <sup>1</sup>
<b>Aggregate Type &amp; PSV</b>	Gritstone 60
<b>Thickness Found (mm)</b>	34
<b>1) Bound Material Type</b>	14mm 35% HRA
<b>Thickness Found (mm)</b>	19
<b>2) Bound Material Type</b>	32mm A/C
<b>Thickness Found (mm)</b>	58
<b>3) Bound Material Type</b>	32mm A/C <sup>1</sup>
<b>Thickness Found</b>	88
<b>4) Bound Material Type</b>	32mm A/C
<b>Thickness Found (mm)</b>	75
<b>Foundation Material</b>	Granular subbase
<b>Significant Quantity Lifted</b>	No
<b>WAC Potentially Required</b>	Yes
