[BNES Keynsham bypass Report 11367-2016.pdf](#)

North Somerset Council Highway Services Laboratory

REPORT No: 11/03-BCC-Wells Road Bristol-

**TEST : Visual Examination of Cores and Each layer chemically tested for Tar presence and those identified further tested for Waste Acceptance Criteria Certification**

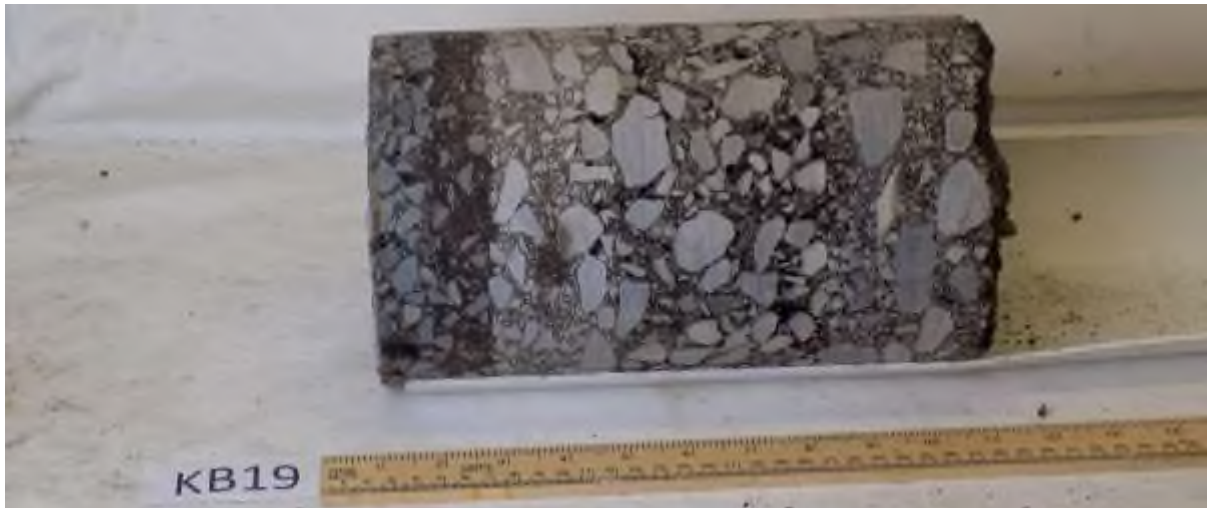
**Plate 20:** Core reference: KB19**Table 20:** Visual examination results and WAC recommendations for core ref: KB19

<b>Core Reference:</b>	KB19
<b>Location</b>	Lane 1, westbound
<b>Total Depth Core (mm)</b>	255
<b>Surface Course Type</b>	14mm SMA <sup>1</sup>
<b>Aggregate Type &amp; PSV</b>	Gritstone 60
<b>Thickness Found (mm)</b>	26
<b>1) Bound Material Type</b>	14mm 35% HRA
<b>Thickness Found (mm)</b>	25
<b>2) Bound Material Type</b>	20mm A/C
<b>Thickness Found (mm)</b>	51
<b>3) Bound Material Type</b>	32mm A/C
<b>Thickness Found</b>	85
<b>4) Bound Material Type</b>	32mm A/C
<b>Thickness Found (mm)</b>	68
<b>Foundation Material</b>	Granular subbase
<b>Significant Quantity Lifted</b>	No
<b>WAC Potentially Required</b>	Yes

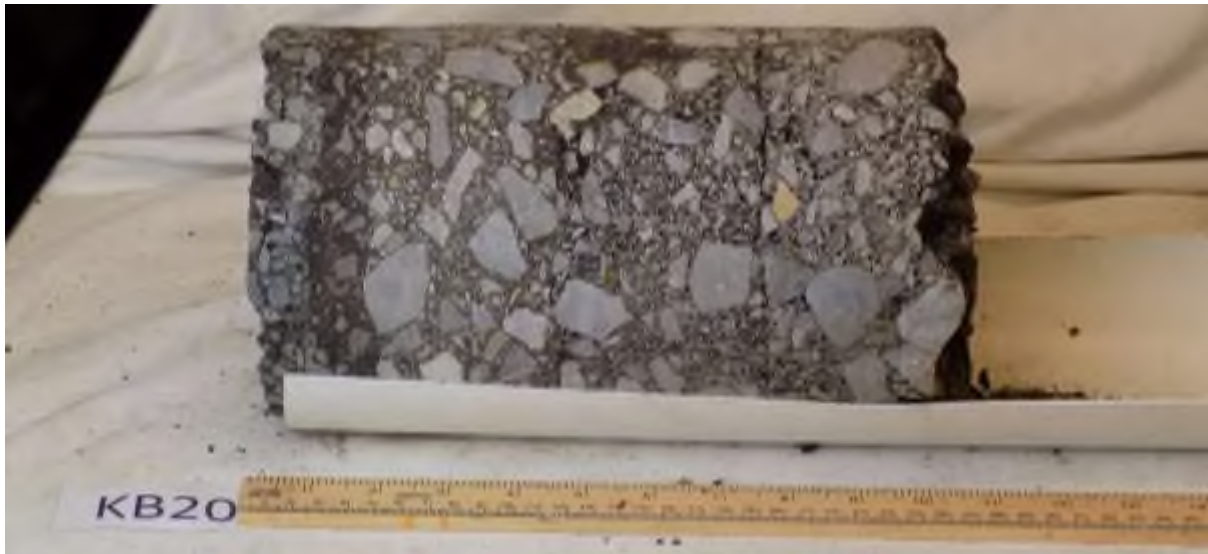
**Plate 21:** Core reference: KB20**Table 21:** Visual examination results and WAC recommendations for core ref: KB20

<b>Core Reference:</b>	KB20
<b>Location</b>	Lane 2 westbound
<b>Total Depth Core (mm)</b>	255
<b>Surface Course Type</b>	14mm SMA <sup>1</sup>
<b>Aggregate Type &amp; PSV</b>	Gritstone 60
<b>Thickness Found (mm)</b>	23
<b>1) Bound Material Type</b>	14mm 35% HRA
<b>Thickness Found (mm)</b>	21
<b>2) Bound Material Type</b>	20mm A/C
<b>Thickness Found (mm)</b>	66
<b>3) Bound Material Type</b>	32mm A/C
<b>Thickness Found</b>	75
<b>4) Bound Material Type</b>	32mm A/C
<b>Thickness Found (mm)</b>	70
<b>Foundation Material</b>	Granular subbase
<b>Significant Quantity Lifted</b>	No
<b>WAC Potentially Required</b>	Yes

**Remarks:** Tar present in 32mm A/C

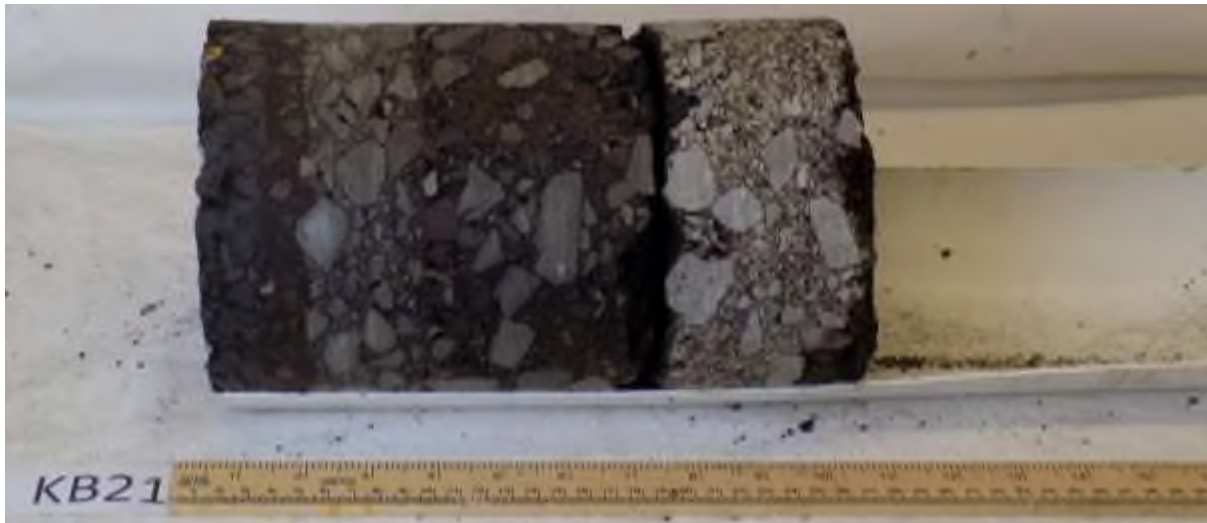
**Plate 22:** Core reference: KB21**Table 22:** Visual examination results and WAC recommendations for core ref: KB21

<b>Core Reference:</b>	KB21
<b>Location</b>	Lane 1, westbound
<b>Total Depth Core (mm)</b>	249
<b>Surface Course Type</b>	14mm SMA <sup>1</sup>
<b>Aggregate Type &amp; PSV</b>	Gritstone 60
<b>Thickness Found (mm)</b>	22
<b>1) Bound Material Type</b>	14mm 35% HRA
<b>Thickness Found (mm)</b>	18
<b>2) Bound Material Type</b>	20mm A/C
<b>Thickness Found (mm)</b>	44
<b>3) Bound Material Type</b>	32mm A/C
<b>Thickness Found</b>	85
<b>4) Bound Material Type</b>	32mm A/C
<b>Thickness Found (mm)</b>	80
<b>Foundation Material</b>	Granular subbase
<b>Significant Quantity Lifted</b>	No
<b>WAC Potentially Required</b>	Yes

**Remarks:** Tar present in 32mm A/C

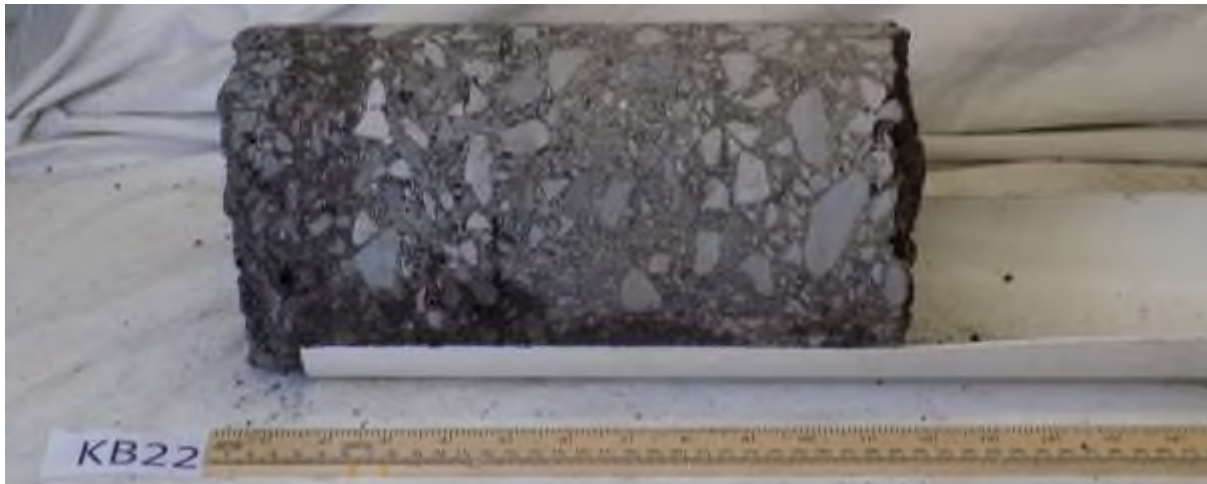
**Plate 23:** Core reference: KB22**Table 23:** Visual examination results and WAC recommendations for core ref: KB22

<b>Core Reference:</b>	KB22
<b>Location</b>	Lane 2, westbound
<b>Total Depth Core (mm)</b>	283
<b>Surface Course Type</b>	14mm SMA <sup>1</sup>
<b>Aggregate Type &amp; PSV</b>	Gritstone 60
<b>Thickness Found (mm)</b>	25
<b>1) Bound Material Type</b>	14mm 35% HRA
<b>Thickness Found (mm)</b>	34
<b>2) Bound Material Type</b>	20mm A/C
<b>Thickness Found (mm)</b>	58
<b>3) Bound Material Type</b>	32mm A/C
<b>Thickness Found</b>	81
<b>4) Bound Material Type</b>	32mm A/C
<b>Thickness Found (mm)</b>	85
<b>Foundation Material</b>	Granular subbase
<b>Significant Quantity Lifted</b>	No
<b>WAC Potentially Required</b>	Yes

**Remarks:** Tar present in 32mm A/C

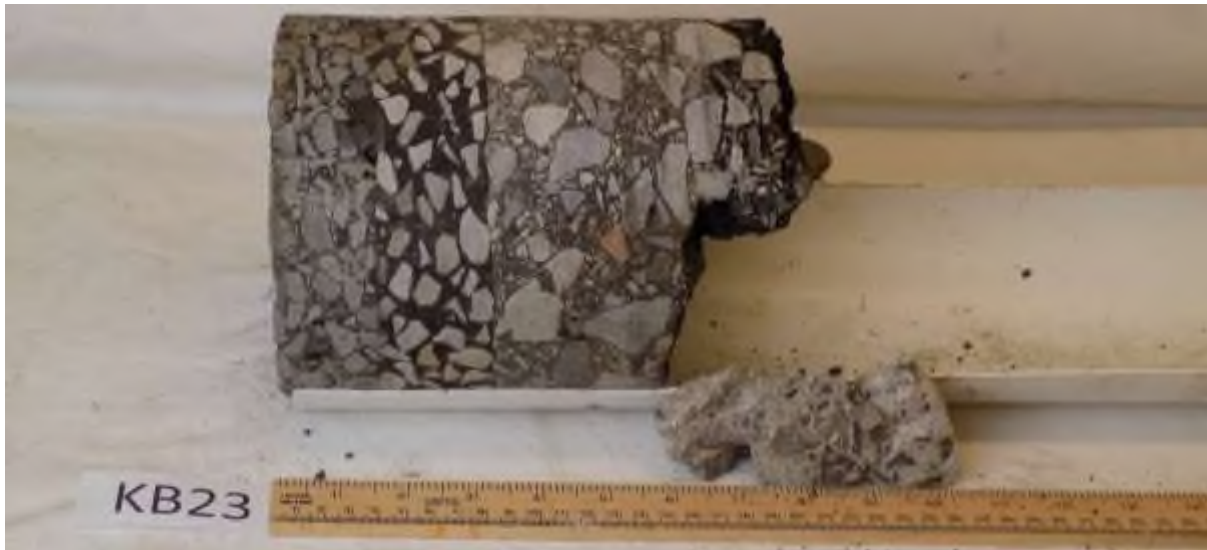
**Plate 24:** Core reference: KB23**Table 24:** Visual examination results and WAC recommendations for core ref: KB23

<b>Core Reference:</b>	KB23	
<b>Location</b>	Just off the far side of the bridge deck	
<b>Total Depth Core (mm)</b>	146-161	
<b>Surface Course Type</b>	14mm SMA <sup>1</sup>	
<b>Aggregate Type &amp; PSV</b>	Gritstone 60	
<b>Thickness Found (mm)</b>	38	
<b>1) Bound Material Type</b>	14mm 35% HRA	
<b>Thickness Found (mm)</b>	43	
<b>2) Bound Material Type</b>	32mm A/C	
<b>Thickness Found (mm)</b>	65-80	
<b>Foundation Material</b>	Concrete	32mm A/C
<b>Significant Quantity Lifted</b>	No	No
<b>WAC Potentially Required</b>	Yes

**Remarks:** Core was taken just off the bridge deck. The concrete that was recovered is thought to be the end of the bridge abutment as it was only present in the half of the core closest to the bridge and had a clean edge. Tar present in some 32mm A/C, The depth of 32 mm AC (layer 2) includes 15 mm of overlap with concrete. Further 32 mm AC was present below.

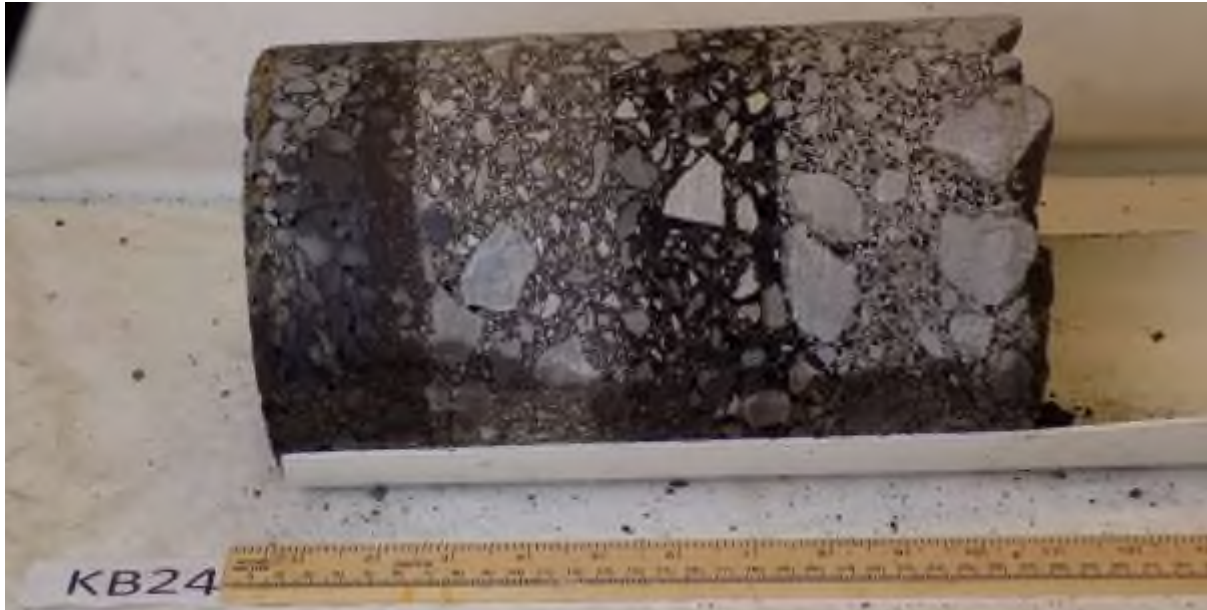
**Plate 25:** Core reference: KB24**Table 25:** Visual examination results and WAC recommendations for core ref: KB24

<b>Core Reference:</b>	KB24
<b>Location</b>	Lane 1, westbound
<b>Total Depth Core (mm)</b>	257
<b>Surface Course Type</b>	14mm SMA <sup>1</sup>
<b>Aggregate Type &amp; PSV</b>	Gritstone 60
<b>Thickness Found (mm)</b>	38
<b>1) Bound Material Type</b>	14mm 35% HRA
<b>Thickness Found (mm)</b>	16
<b>2) Bound Material Type</b>	20mm A/C
<b>Thickness Found (mm)</b>	65
<b>3) Bound Material Type</b>	32mm A/C
<b>Thickness Found</b>	54
<b>4) Bound Material Type</b>	32mm A/C
<b>Thickness Found (mm)</b>	84
<b>Foundation Material</b>	Granular subbase
<b>Significant Quantity Lifted</b>	No
<b>WAC Potentially Required</b>	Yes

**Remarks:** Tar present in 32mm A/C

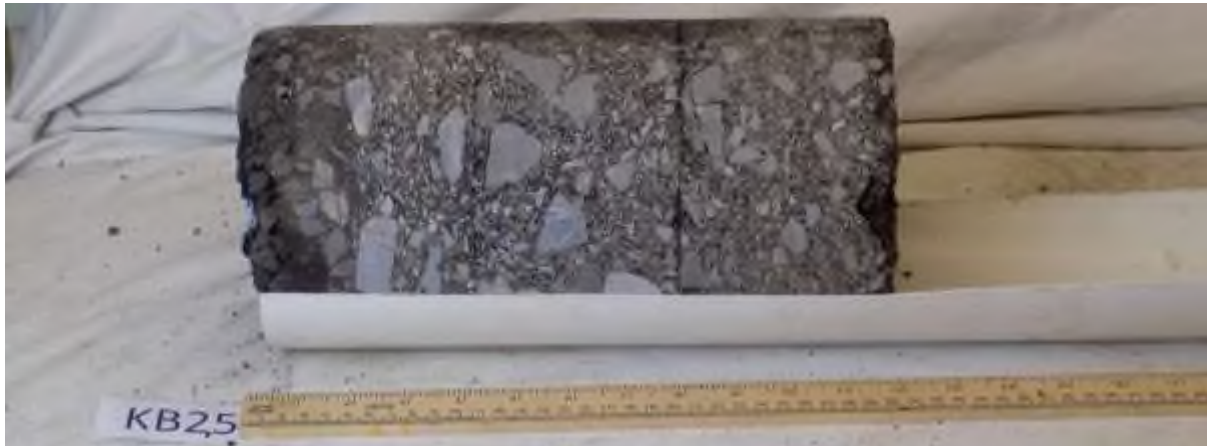
**Plate 26:** Core reference: KB25**Table 26:** Visual examination results and WAC recommendations for core ref: KB25

<b>Core Reference:</b>	KB25
<b>Location</b>	Lane 2, westbound
<b>Total Depth Core (mm)</b>	288
<b>Surface Course Type</b>	14mm SMA <sup>1</sup>
<b>Aggregate Type &amp; PSV</b>	Gritstone 60
<b>Thickness Found (mm)</b>	21
<b>1) Bound Material Type</b>	14mm 35% HRA*
<b>Thickness Found (mm)</b>	21
<b>2) Bound Material Type</b>	32mm A/C*
<b>Thickness Found (mm)</b>	55
<b>3) Bound Material Type</b>	32mm A/C
<b>Thickness Found</b>	91
<b>4) Bound Material Type</b>	32mm A/C
<b>Thickness Found (mm)</b>	93
<b>Foundation Material</b>	Granular subbase
<b>Significant Quantity Lifted</b>	No
<b>WAC Potentially Required</b>	Yes

**Remarks:** Tar present in some 32mm A/C. \* Bound layers 1 and 2 had a mild PAK marker reaction, unusual as none of the surrounding HRA reacted. Please be aware that the strength of reaction does not indicate the amount of tar present.

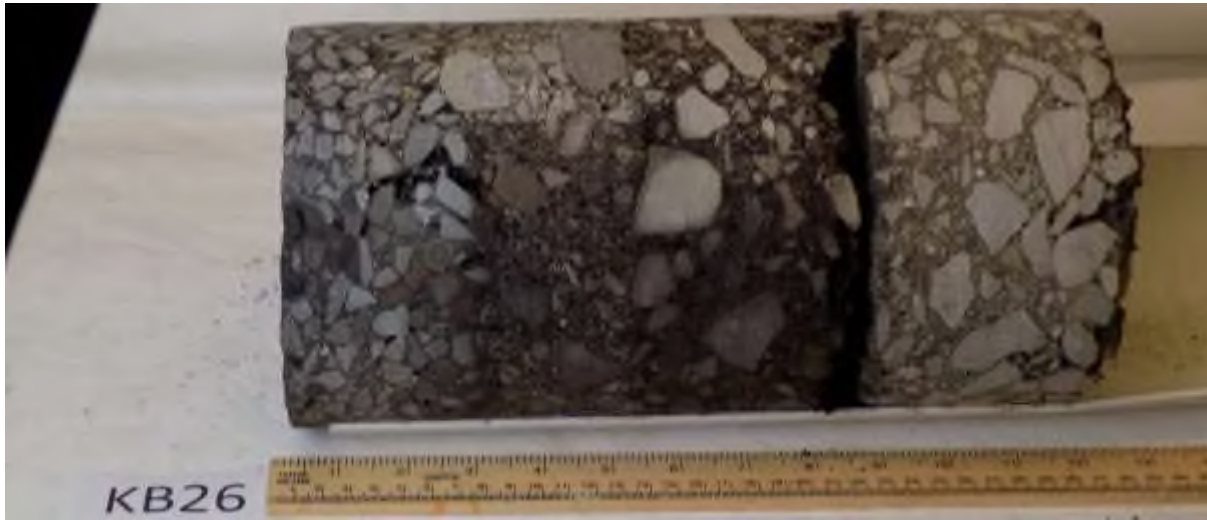
**Plate 27:** Core reference: KB26**Table 27:** Visual examination results and WAC recommendations for core ref: KB26

<b>Core Reference:</b>	KB26
<b>Location</b>	Lane 1 westbound
<b>Total Depth Core (mm)</b>	269-308
<b>Surface Course Type</b>	14mm SMA <sup>1</sup>
<b>Aggregate Type &amp; PSV</b>	Gritstone 60
<b>Thickness Found (mm)</b>	74-56
<b>1) Bound Material Type</b>	20mm A/C
<b>Thickness Found (mm)</b>	66-45
<b>2) Bound Material Type</b>	32mm A/C <sup>7</sup>
<b>Thickness Found (mm)</b>	77
<b>3) Bound Material Type</b>	32mm A/C
<b>Thickness Found</b>	91
<b>Foundation Material</b>	Granular subbase
<b>Significant Quantity Lifted</b>	No
<b>WAC Potentially Required</b>	Yes

**Remarks:** Tar present in 32mm A/C

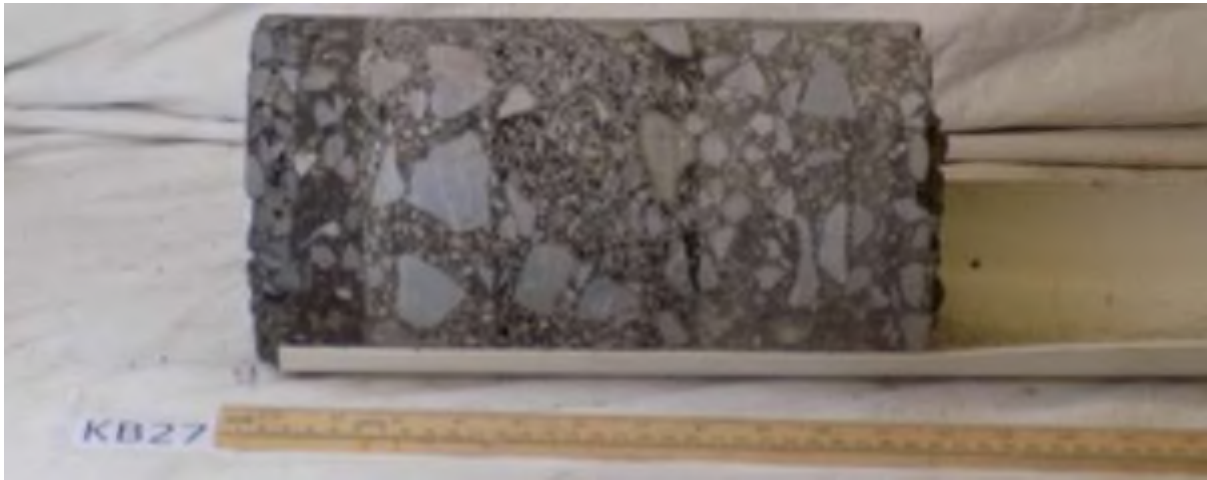
**Plate 28:** Core reference: KB27**Table 28:** Visual examination results and WAC recommendations for core ref: KB27

<b>Core Reference:</b>	KB27
<b>Location</b>	Lane 2, westbound
<b>Total Depth Core (mm)</b>	280
<b>Surface Course Type</b>	14mm SMA <sup>1</sup>
<b>Aggregate Type &amp; PSV</b>	Gritstone 60
<b>Thickness Found (mm)</b>	20
<b>1) Bound Material Type</b>	14mm 35% HRA
<b>Thickness Found (mm)</b>	26
<b>2) Bound Material Type</b>	32mm A/C
<b>Thickness Found (mm)</b>	52
<b>3) Bound Material Type</b>	32mm A/C
<b>Thickness Found</b>	84
<b>4) Bound Material Type</b>	32mm A/C
<b>Thickness Found (mm)</b>	98
<b>Foundation Material</b>	Granular subbase
<b>Significant Quantity Lifted</b>	No
<b>WAC Potentially Required</b>	Yes

**Remarks:** Tar present in some 32mm A/C

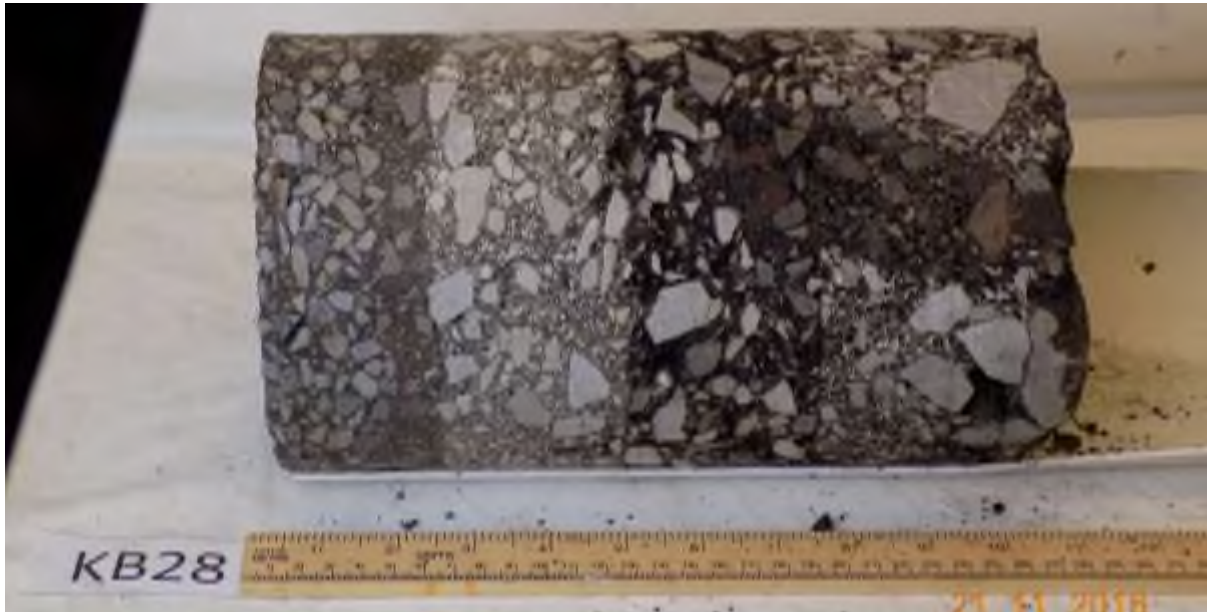
**Plate 29:** Core reference: KB28**Table 29:** Visual examination results and WAC recommendations for core ref: KB28

<b>Core Reference:</b>	KB28
<b>Location</b>	Lane 1 westbound
<b>Total Depth Core (mm)</b>	256
<b>Surface Course Type</b>	14mm SMA <sup>1</sup>
<b>Aggregate Type &amp; PSV</b>	Gritstone 60
<b>Thickness Found (mm)</b>	38
<b>1) Bound Material Type</b>	14mm 35% HRA
<b>Thickness Found (mm)</b>	17
<b>2) Bound Material Type</b>	20mm A/C
<b>Thickness Found (mm)</b>	59
<b>3) Bound Material Type</b>	32mm A/C <sup>1</sup>
<b>Thickness Found</b>	62
<b>4) Bound Material Type</b>	32mm A/C <sup>1</sup>
<b>Thickness Found (mm)</b>	80
<b>Foundation Material</b>	Granular subbase
<b>Significant Quantity Lifted</b>	No
<b>WAC Potentially Required</b>	Yes

**Remarks:** Tar present in 32mm A/C

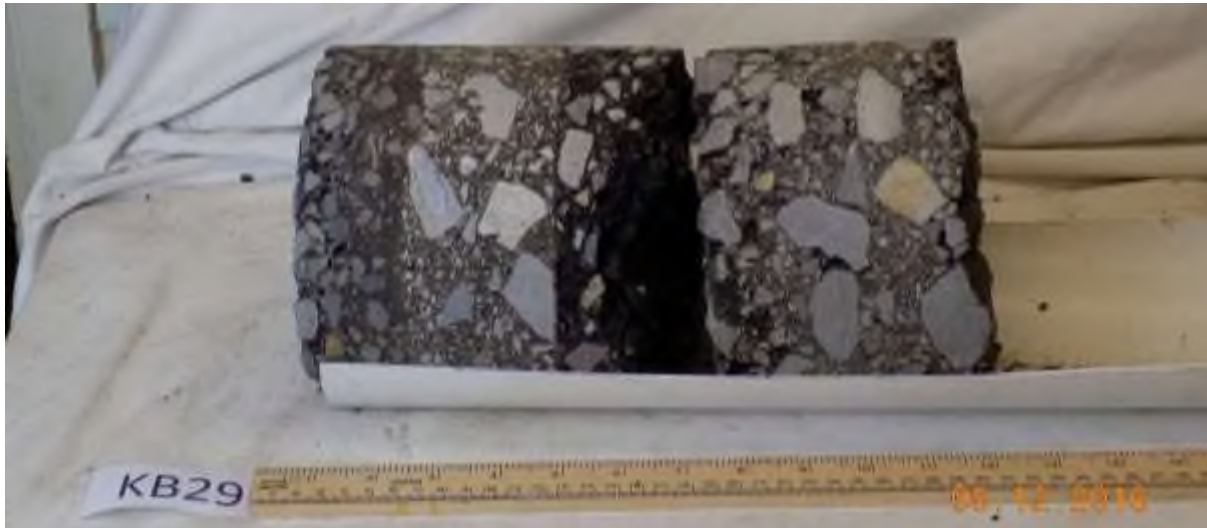
**Plate 30:** Core reference: KB29**Table 30:** Visual examination results and WAC recommendations for core ref: KB29

<b>Core Reference:</b>	KB29
<b>Location</b>	Lane 2, westbound
<b>Total Depth Core (mm)</b>	273
<b>Surface Course Type</b>	14mm SMA
<b>Aggregate Type &amp; PSV</b>	Gritstone 60
<b>Thickness Found (mm)</b>	23
<b>1) Bound Material Type</b>	14mm 35% HRA
<b>Thickness Found (mm)</b>	27
<b>2) Bound Material Type</b>	32mm A/C
<b>Thickness Found (mm)</b>	63
<b>3) Bound Material Type</b>	20mm A/C <sup>7,3</sup>
<b>Thickness Found</b>	50
<b>4) Bound Material Type</b>	32mm A/C
<b>Thickness Found (mm)</b>	110
<b>Foundation Material</b>	Granular subbase
<b>Significant Quantity Lifted</b>	No
<b>WAC Potentially Required</b>	Yes

**Remarks:** Tar present in 20mm A/C and some 32mm A/C

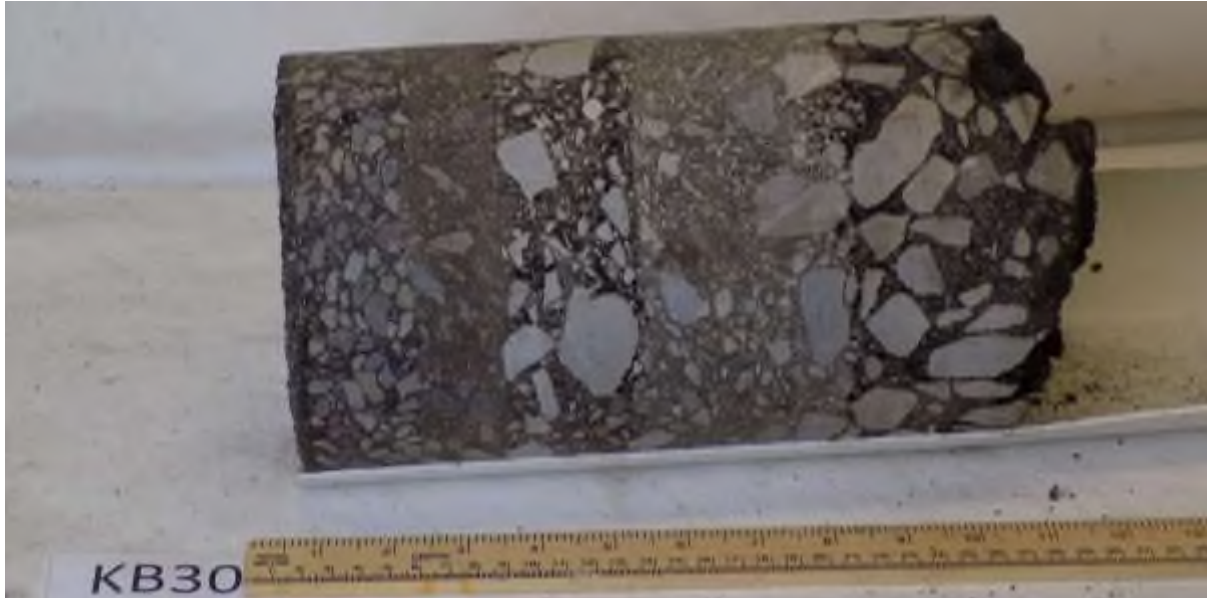
**Plate 31:** Core reference: KB30**Table 31:** Visual examination results and WAC recommendations for core ref: KB30

<b>Core Reference:</b>	KB30
<b>Location</b>	Lane 1, westbound
<b>Total Depth Core (mm)</b>	263
<b>Surface Course Type</b>	High Friction surfacing
<b>Aggregate Type &amp; PSV</b>	Calcined Bauxite 68
<b>Thickness Found (mm)</b>	5
<b>1) Bound Material Type</b>	10mm SMA
<b>Thickness Found (mm)</b>	38
<b>2) Bound Material Type</b>	14mm 35% HRA
<b>Thickness Found (mm)</b>	29
<b>3) Bound Material Type</b>	20mm A/C
<b>Thickness Found</b>	44
<b>4) Bound Material Type</b>	32mm A/C
<b>Thickness Found (mm)</b>	72
<b>5) Bound Material Type</b>	32mm A/C
<b>Thickness Found (mm)</b>	75
<b>Foundation Material</b>	Granular subbase
<b>Significant Quantity Lifted</b>	No
<b>WAC Potentially Required</b>	Yes

**Remarks:** Tar present in 32mm A/C

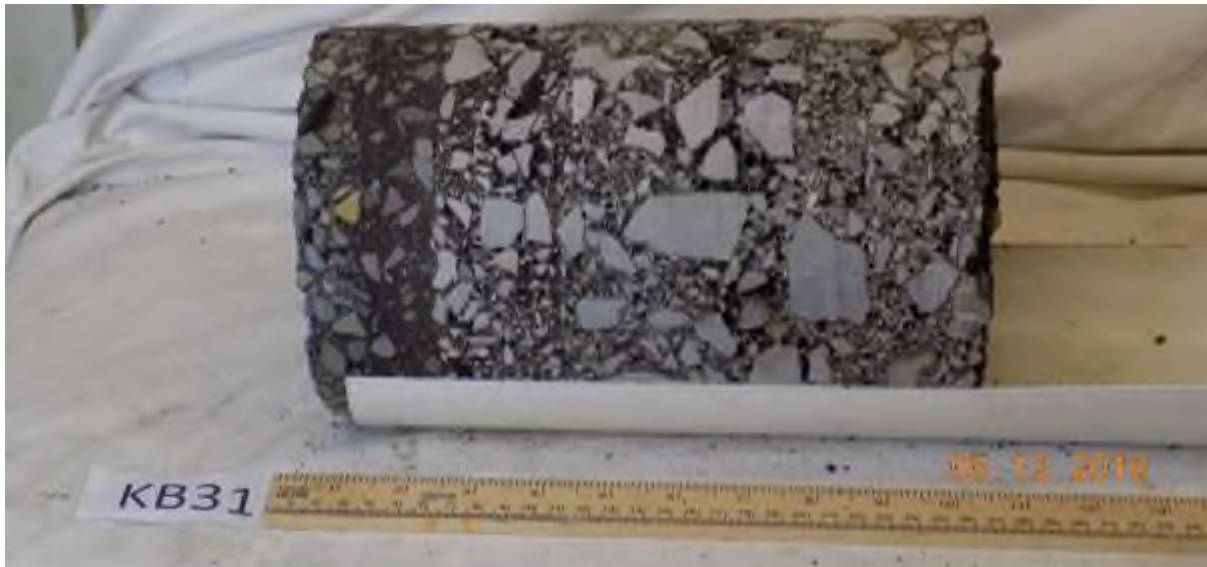
**Plate 32:** Core reference: KB31**Table 32:** Visual examination results and WAC recommendations for core ref: KB31

<b>Core Reference:</b>	KB31
<b>Location</b>	Lane 2 westbound
<b>Total Depth Core (mm)</b>	240
<b>Surface Course Type</b>	14mm SMA <sup>1</sup>
<b>Aggregate Type &amp; PSV</b>	Gritstone 60
<b>Thickness Found (mm)</b>	22
<b>1) Bound Material Type</b>	14mm 35% HRA
<b>Thickness Found (mm)</b>	25
<b>2) Bound Material Type</b>	20mm A/C <sup>1</sup>
<b>Thickness Found (mm)</b>	44
<b>3) Bound Material Type</b>	32mm A/C <sup>1</sup>
<b>Thickness Found</b>	63
<b>4) Bound Material Type</b>	32mm A/C
<b>Thickness Found (mm)</b>	86
<b>Foundation Material</b>	Granular subbase
<b>Significant Quantity Lifted</b>	No
<b>WAC Potentially Required</b>	Yes

**Remarks:** Tar present in 32mm A/C

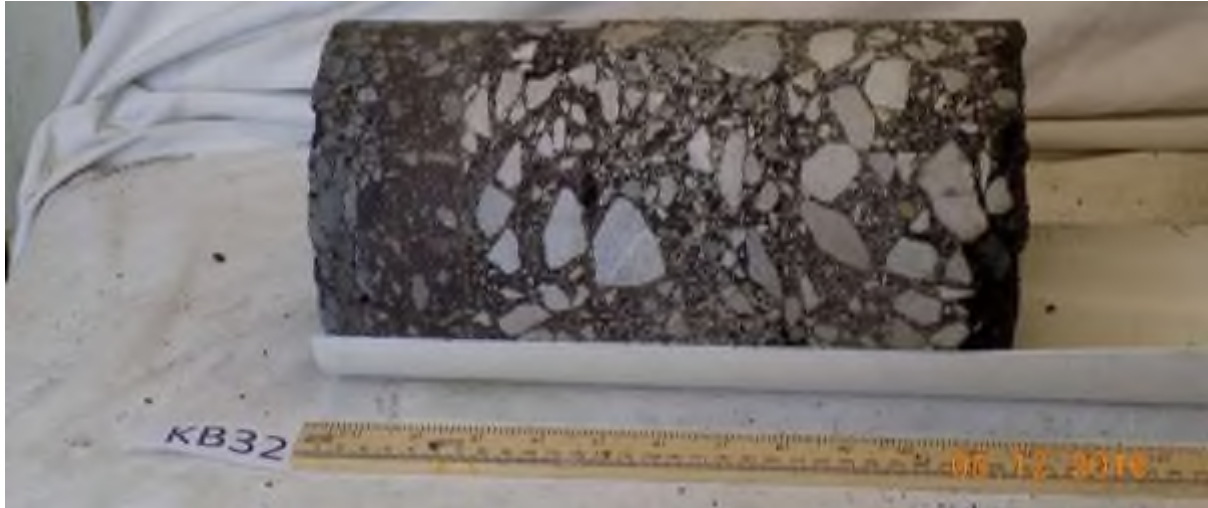
**Plate 33:** Core reference: KB32**Table 33:** Visual examination results and WAC recommendations for core ref: KB32

<b>Core Reference:</b>	KB32
<b>Location</b>	Lane 1 westbound
<b>Total Depth Core (mm)</b>	274
<b>Surface Course Type</b>	14mm SMA <sup>1</sup>
<b>Aggregate Type &amp; PSV</b>	Gritstone 60
<b>Thickness Found (mm)</b>	20
<b>1) Bound Material Type</b>	14mm 35% HRA
<b>Thickness Found (mm)</b>	38
<b>2) Bound Material Type</b>	20mm A/C <sup>1</sup>
<b>Thickness Found (mm)</b>	50
<b>3) Bound Material Type</b>	32mm A/C <sup>1</sup>
<b>Thickness Found</b>	76
<b>4) Bound Material Type</b>	32mm A/C
<b>Thickness Found (mm)</b>	90
<b>Foundation Material</b>	Granular subbase
<b>Significant Quantity Lifted</b>	No
<b>WAC Potentially Required</b>	Yes

**Remarks:** Tar present in 32mm A/C

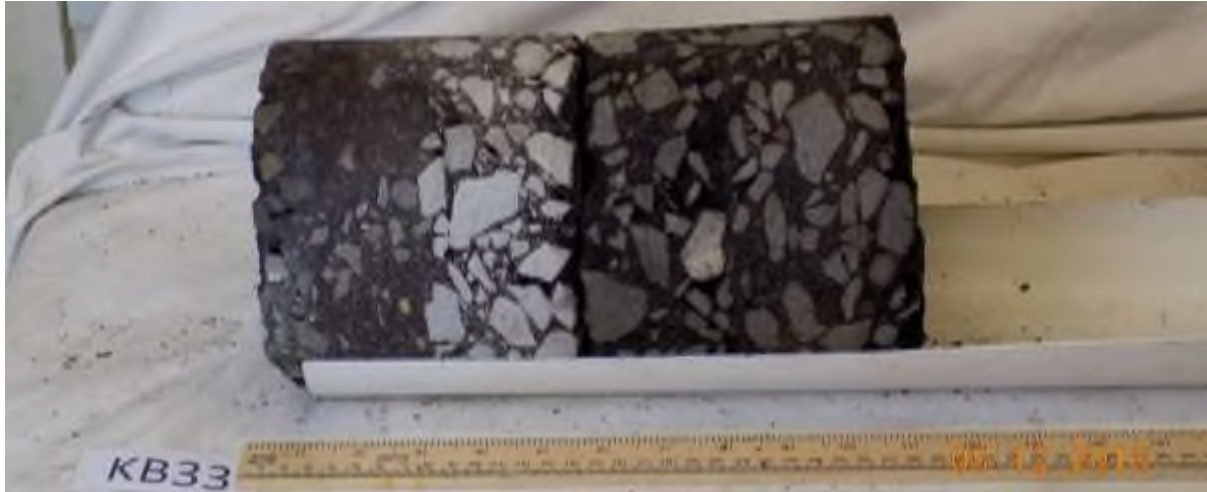
**Plate 34:** KB33**Table 34:** Visual Examination results and WAC recommendations for core ref: KB33

<b>Core Reference:</b>	KB33
<b>Location</b>	Lane 2, westbound
<b>Total Depth Core (mm)</b>	262
<b>Surface Course Type</b>	14mm SMA <sup>1</sup>
<b>Aggregate Type &amp; PSV</b>	Gritstone 60
<b>Thickness Found (mm)</b>	24
<b>1) Bound Material Type</b>	14mm 35% HRA
<b>Thickness Found (mm)</b>	46
<b>2) Bound Material Type</b>	20mm A/C <sup>7,1</sup>
<b>Thickness Found (mm)</b>	55
<b>3) Bound Material Type</b>	32mm A/C <sup>1</sup>
<b>Thickness Found</b>	63
<b>4) Bound Material Type</b>	32mm A/C
<b>Thickness Found (mm)</b>	74
<b>Foundation Material</b>	Granular subbase
<b>Significant Quantity Lifted</b>	No
<b>WAC Potentially Required</b>	Yes

**Remarks:** Tar present in 32mm A/C

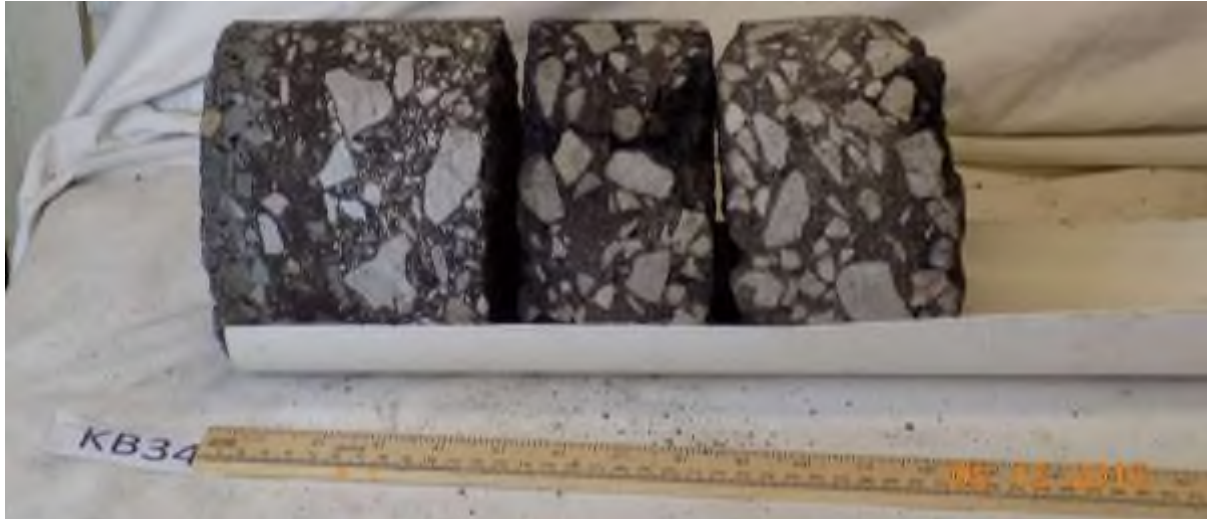
**Plate 35:** Core reference: KB34**Table 35:** Visual examination results and WAC recommendations for core ref: KB34

<b>Core Reference:</b>	KB34
<b>Location</b>	Lane 1, westbound
<b>Total Depth Core (mm)</b>	285
<b>Surface Course Type</b>	14mm SMA <sup>1</sup>
<b>Aggregate Type &amp; PSV</b>	Gritstone 60
<b>Thickness Found (mm)</b>	22
<b>1) Bound Material Type</b>	14mm HRA
<b>Thickness Found (mm)</b>	28
<b>2) Bound Material Type</b>	32mm A/C <sup>7</sup>
<b>Thickness Found (mm)</b>	65
<b>3) Bound Material Type</b>	32mm A/C <sup>7</sup>
<b>Thickness Found</b>	90
<b>4) Bound Material Type</b>	32mm A/C <sup>10</sup>
<b>Thickness Found (mm)</b>	80
<b>Foundation Material</b>	Granular subbase
<b>Significant Quantity Lifted</b>	No
<b>WAC Potentially Required</b>	Yes

**Remarks:** Tar present in 32mm A/C

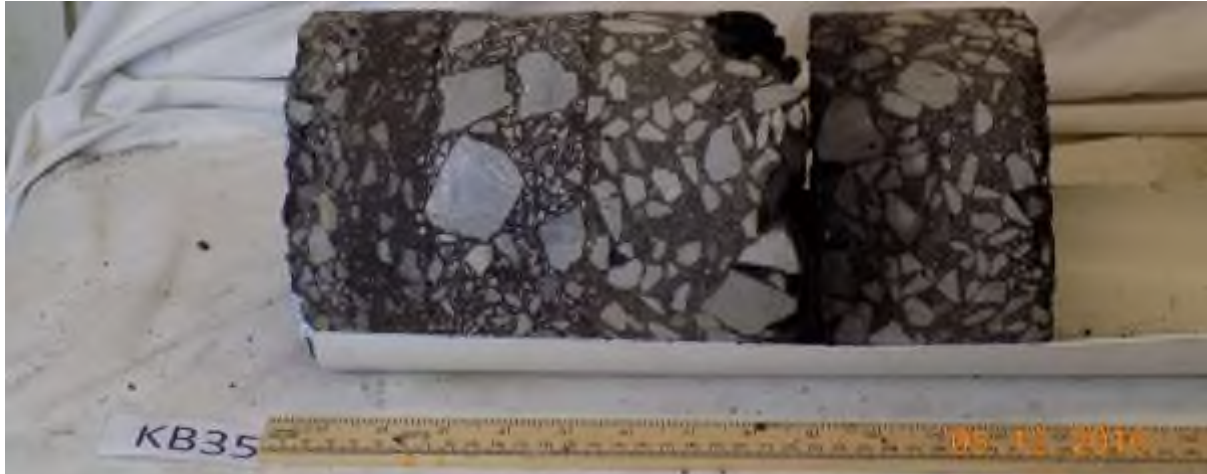
**Plate 36:** Core reference: KB35**Table 36:** Visual examination results and WAC recommendations for core ref: KB35

<b>Core Reference:</b>	KB35
<b>Location</b>	Lane 2, westbound
<b>Total Depth Core (mm)</b>	290
<b>Surface Course Type</b>	14mm SMA <sup>1</sup>
<b>Aggregate Type &amp; PSV</b>	Gritstone 60
<b>Thickness Found (mm)</b>	28
<b>1) Bound Material Type</b>	14mm 35% HRA
<b>Thickness Found (mm)</b>	32
<b>2) Bound Material Type</b>	32mm A/C
<b>Thickness Found (mm)</b>	58
<b>3) Bound Material Type</b>	32mm A/C <sup>7,3</sup>
<b>Thickness Found</b>	85
<b>4) Bound Material Type</b>	32mm A/C
<b>Thickness Found (mm)</b>	87
<b>Foundation Material</b>	Granular subbase
<b>Significant Quantity Lifted</b>	No
<b>WAC Potentially Required</b>	Yes

**Remarks:** Tar present in 32mm A/C

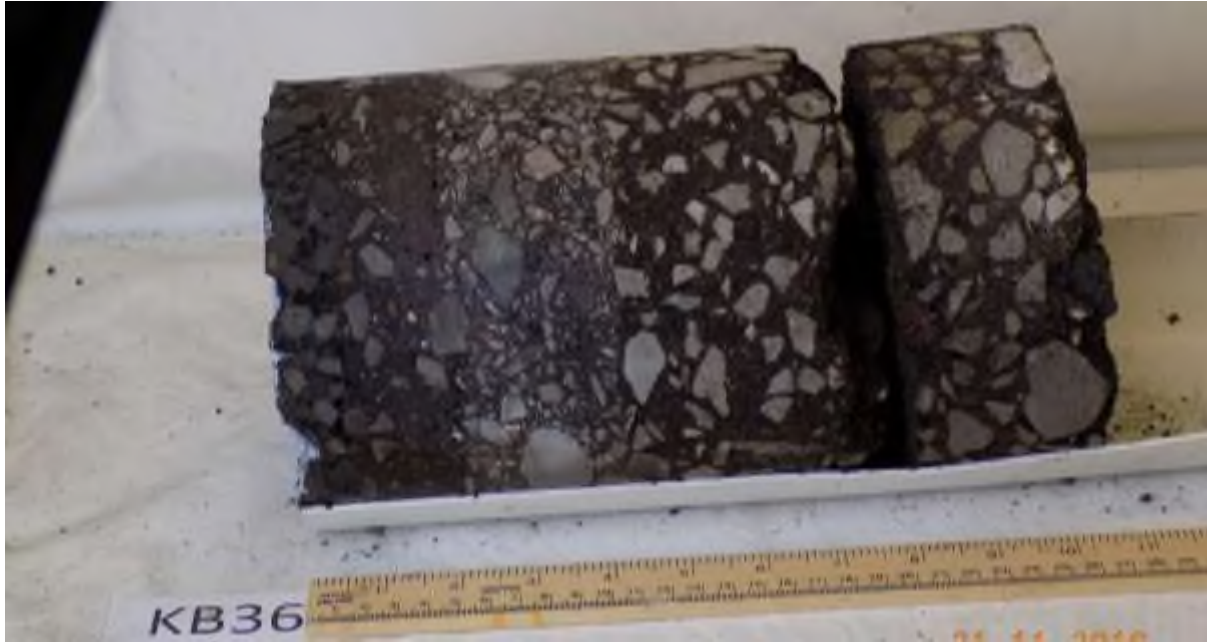
**Plate 37:** Core reference: KB36**Table 37:** Visual examination results and WAC recommendations for core ref: KB36

<b>Core Reference:</b>	KB36
<b>Location</b>	Lane 1, westbound
<b>Total Depth Core (mm)</b>	249
<b>Surface Course Type</b>	14mm SMA <sup>1</sup>
<b>Aggregate Type &amp; PSV</b>	Gritstone 60
<b>Thickness Found (mm)</b>	26
<b>1) Bound Material Type</b>	14mm 35% HRA
<b>Thickness Found (mm)</b>	38
<b>2) Bound Material Type</b>	20mm A/C
<b>Thickness Found (mm)</b>	46
<b>3) Bound Material Type</b>	32mm A/C
<b>Thickness Found</b>	75
<b>4) Bound Material Type</b>	32mm A/C
<b>Thickness Found (mm)</b>	64
<b>Foundation Material</b>	Granular subbase
<b>Significant Quantity Lifted</b>	No
<b>WAC Potentially Required</b>	Yes

**Remarks:** Tar present in some 32mm A/C

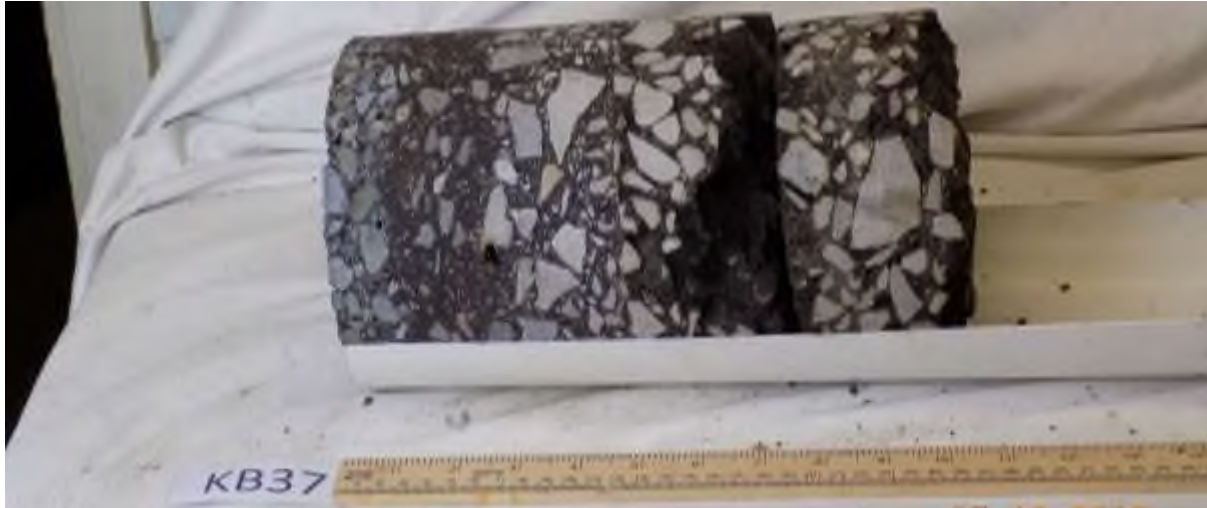
**Plate 38:** Core reference: KB37**Table 38:** Visual examination results and WAC recommendations for core ref: KB37

<b>Core Reference:</b>	KB37
<b>Location</b>	Lane 2, westbound
<b>Total Depth Core (mm)</b>	249
<b>Surface Course Type</b>	14mm SMA <sup>1</sup>
<b>Aggregate Type &amp; PSV</b>	Gritstone 60
<b>Thickness Found (mm)</b>	26
<b>1) Bound Material Type</b>	14mm 35% HRA
<b>Thickness Found (mm)</b>	40
<b>2) Bound Material Type</b>	32mm A/C
<b>Thickness Found (mm)</b>	55
<b>3) Bound Material Type</b>	32mm A/C <sup>3,7</sup>
<b>Thickness Found</b>	60
<b>4) Bound Material Type</b>	32mm A/C
<b>Thickness Found (mm)</b>	68
<b>Foundation Material</b>	Granular subbase
<b>Significant Quantity Lifted</b>	No
<b>WAC Potentially Required</b>	Yes

**Remarks:** Tar present in some 32mm A/C

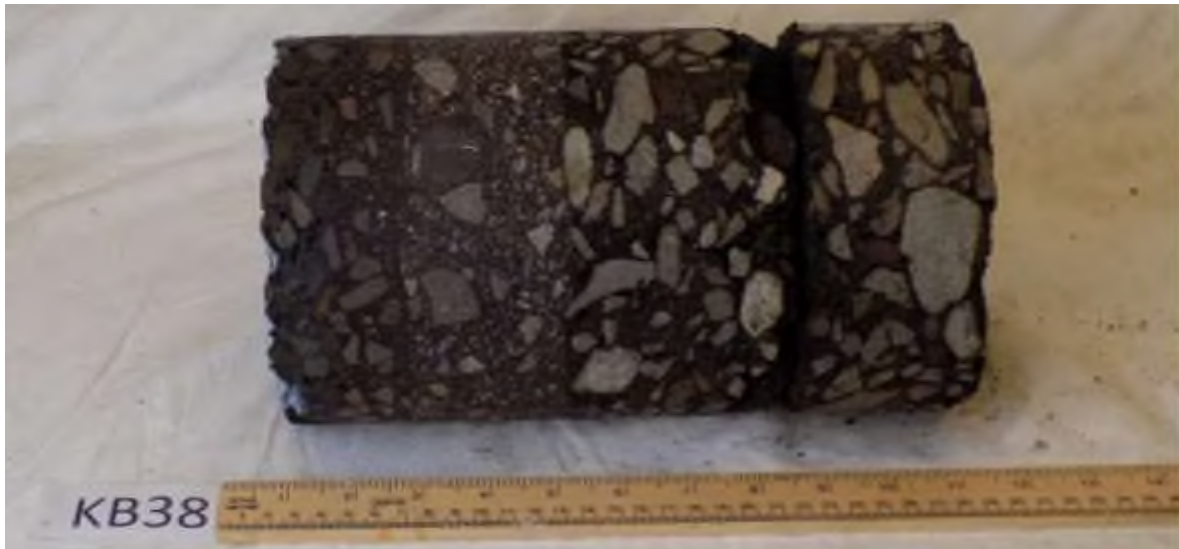
**Plate 39:** Core reference: KB38**Table 39:** Visual examination results and WAC recommendations for core ref: KB38

<b>Core Reference:</b>	KB38
<b>Location</b>	Lane 1, westbound
<b>Total Depth Core (mm)</b>	268
<b>Surface Course Type</b>	14mm SMA <sup>1</sup>
<b>Aggregate Type &amp; PSV</b>	Gritstone 60
<b>Thickness Found (mm)</b>	28
<b>1) Bound Material Type</b>	14mm 35% HRA
<b>Thickness Found (mm)</b>	28
<b>2) Bound Material Type</b>	20mm A/C
<b>Thickness Found (mm)</b>	54
<b>3) Bound Material Type</b>	32mm A/C <sup>7</sup>
<b>Thickness Found</b>	90
<b>4) Bound Material Type</b>	32mm A/C
<b>Thickness Found (mm)</b>	68
<b>Foundation Material</b>	Granular subbase
<b>Significant Quantity Lifted</b>	No
<b>WAC Potentially Required</b>	Yes

**Remarks:** Tar present in 20mm and 32mm A/C

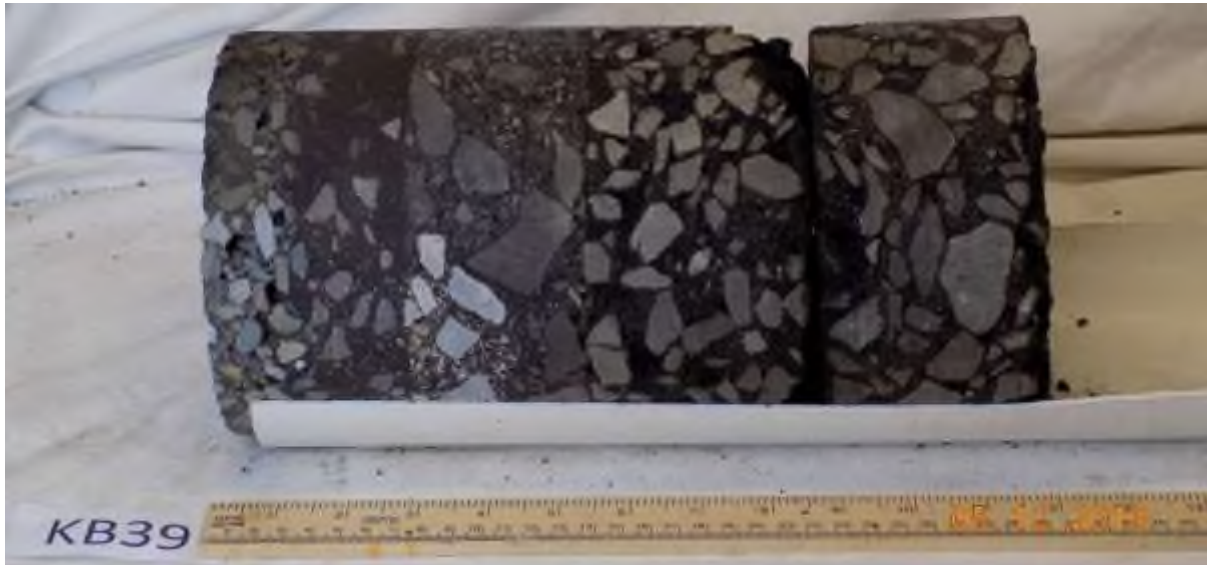
**Plate 40:** Core reference: KB39**Table 40:** Visual examination results and WAC recommendations for core ref: KB39

<b>Core Reference:</b>	KB39
<b>Location</b>	Lane 2, westbound
<b>Total Depth Core (mm)</b>	286
<b>Surface Course Type</b>	14mm SMA <sup>1</sup>
<b>Aggregate Type &amp; PSV</b>	Gritstone 60
<b>Thickness Found (mm)</b>	30
<b>1) Bound Material Type</b>	14mm 35% HRA
<b>Thickness Found (mm)</b>	41
<b>2) Bound Material Type</b>	32mm A/C
<b>Thickness Found (mm)</b>	62
<b>3) Bound Material Type</b>	20mm A/C <sup>1,7</sup>
<b>Thickness Found</b>	75
<b>4) Bound Material Type</b>	32mm A/C
<b>Thickness Found (mm)</b>	78
<b>Foundation Material</b>	Granular subbase
<b>Significant Quantity Lifted</b>	No
<b>WAC Potentially Required</b>	Yes

**Remarks:** Tar present in 20mm and 32mm A/C

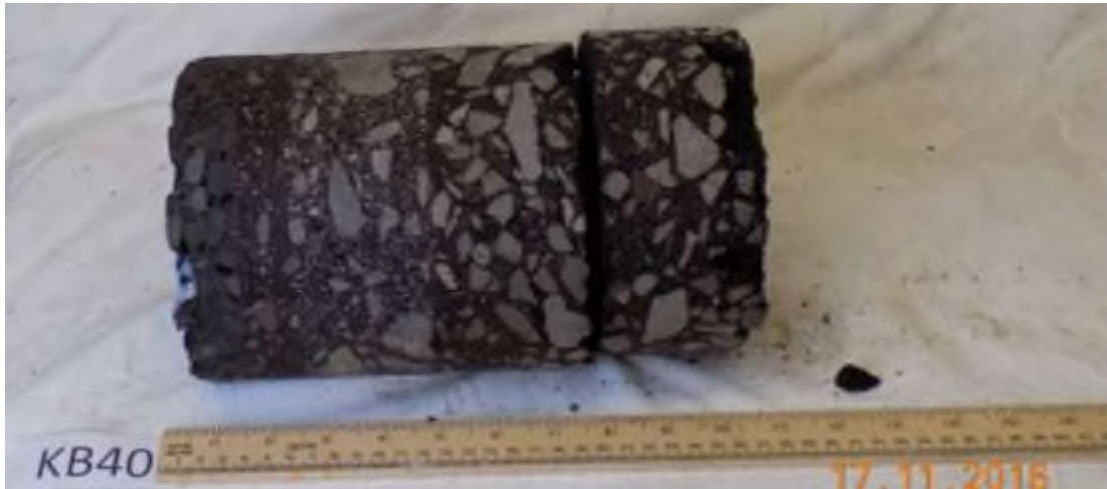
**Plate 41:** Core reference: KB40**Table 41:** Visual examination results and WAC recommendation for core ref: KB40

<b>Core Reference:</b>	KB40
<b>Location</b>	Lane 1, westbound
<b>Total Depth Core (mm)</b>	236
<b>Surface Course Type</b>	14mm SMA <sup>1</sup>
<b>Aggregate Type &amp; PSV</b>	Gritstone 60
<b>Thickness Found (mm)</b>	26
<b>1) Bound Material Type</b>	14mm 35% HRA
<b>Thickness Found (mm)</b>	22
<b>2) Bound Material Type</b>	20mm A/C
<b>Thickness Found (mm)</b>	56
<b>3) Bound Material Type</b>	32mm A/C <sup>7</sup>
<b>Thickness Found</b>	62
<b>4) Bound Material Type</b>	32mm A/C
<b>Thickness Found (mm)</b>	70
<b>Foundation Material</b>	Granular subbase
<b>Significant Quantity Lifted</b>	No
<b>WAC Potentially Required</b>	Yes

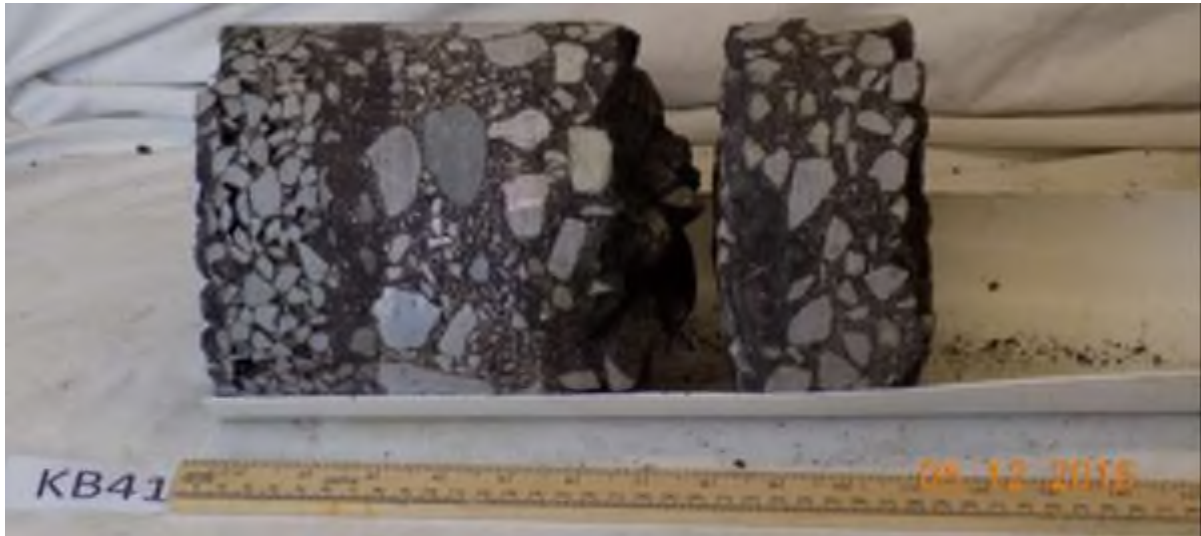
**2.41 Core reference: KB41**

**Plate 42:** Core reference: KB41**Table 42:** Visual examination results and WAC recommendations for core ref: KB41

<b>Core Reference:</b>	KB41
<b>Location</b>	Lane 2, westbound
<b>Total Depth Core (mm)</b>	247
<b>Surface Course Type</b>	14mm SMA <sup>1</sup>
<b>Aggregate Type &amp; PSV</b>	Gritstone 60
<b>Thickness Found (mm)</b>	49
<b>1) Bound Material Type</b>	14mm 35% HRA
<b>Thickness Found (mm)</b>	18
<b>2) Bound Material Type</b>	32mm A/C
<b>Thickness Found (mm)</b>	60
<b>3) Bound Material Type</b>	32mm A/C <sup>3,7</sup>
<b>Thickness Found</b>	50
<b>4) Bound Material Type</b>	32mm A/C
<b>Thickness Found (mm)</b>	70
<b>Foundation Material</b>	Granular subbase
<b>Significant Quantity Lifted</b>	No
<b>WAC Potentially Required</b>	Yes

**Remarks:** Tar present in 32mm A/C

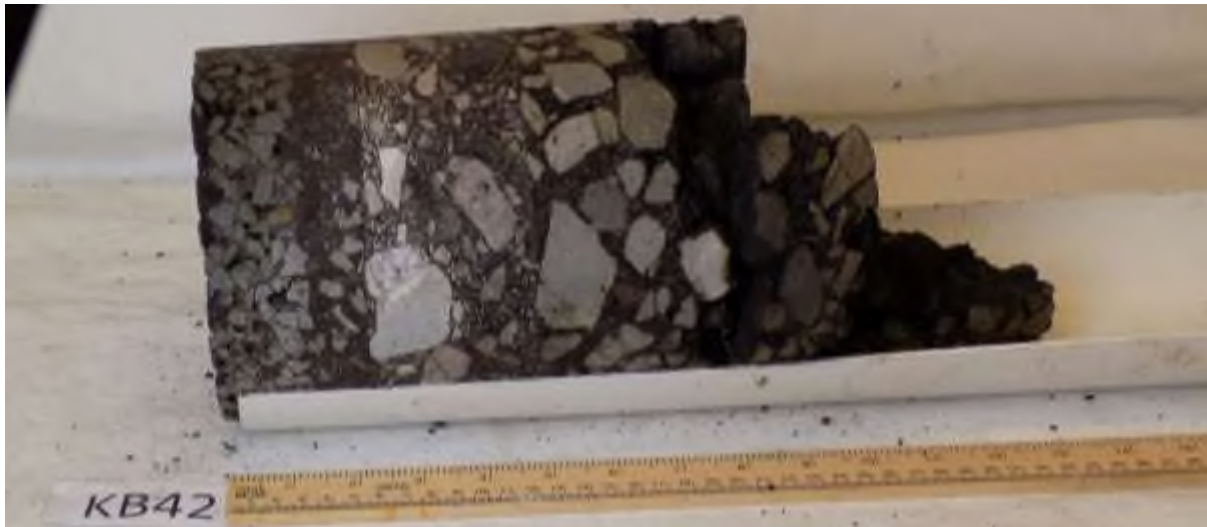
**2.42 Core reference: KB42**

**Plate 43:** Core reference: KB42**Table 43:** Visual examination results and WAC recommendations for core ref: KB42

<b>Core Reference:</b>	KB42
<b>Location</b>	Lane 1, westbound
<b>Total Depth Core (mm)</b>	283
<b>Surface Course Type</b>	14mm SMA <sup>1</sup>
<b>Aggregate Type &amp; PSV</b>	Gritstone 60
<b>Thickness Found (mm)</b>	38
<b>1) Bound Material Type</b>	14mm 35% HRA
<b>Thickness Found (mm)</b>	25
<b>2) Bound Material Type</b>	20mm A/C
<b>Thickness Found (mm)</b>	60
<b>3) Bound Material Type</b>	32mm A/C
<b>Thickness Found</b>	90
<b>4) Bound Material Type</b>	32mm A/C <sup>2</sup>
<b>Thickness Found (mm)</b>	70 (approximately)
<b>Foundation Material</b>	Granular subbase
<b>Significant Quantity Lifted</b>	No
<b>WAC Potentially Required</b>	Yes

**Remarks:** Tar present in 32mm A/C

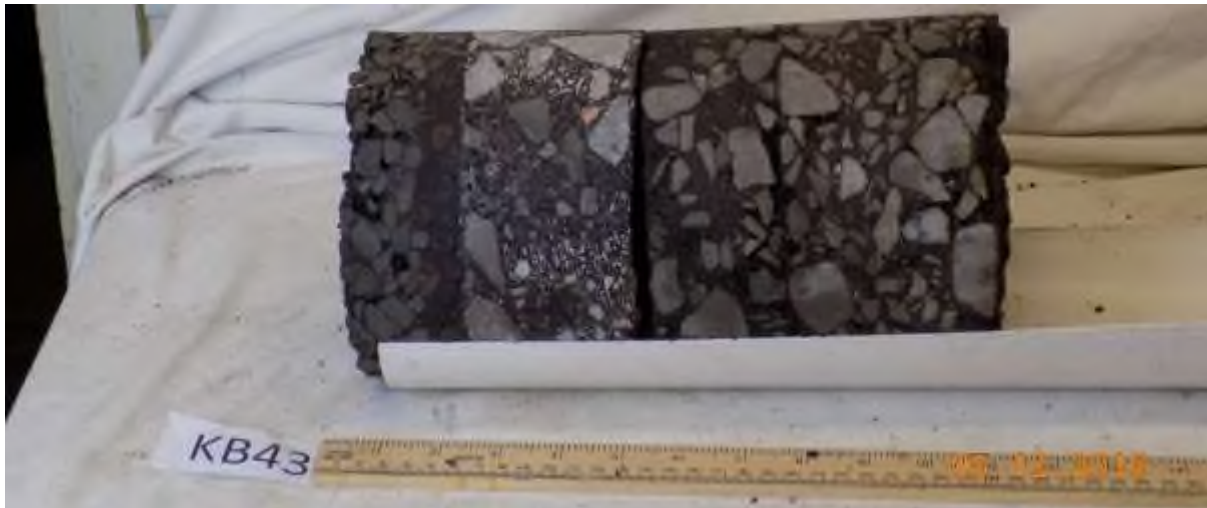
**2.43 Core reference: KB43**

**Plate 44:** Core reference: KB43**Table 44:** Visual examination results and WAC recommendation for core ref: KB43

<b>Core Reference:</b>	KB43
<b>Location</b>	Lane 2, westbound
<b>Total Depth Core (mm)</b>	263
<b>Surface Course Type</b>	14mm SMA <sup>1</sup>
<b>Aggregate Type &amp; PSV</b>	Gritstone 60
<b>Thickness Found (mm)</b>	31
<b>1) Bound Material Type</b>	14mm 35% HRA
<b>Thickness Found (mm)</b>	16
<b>2) Bound Material Type</b>	32mm A/C <sup>7</sup>
<b>Thickness Found (mm)</b>	73
<b>3) Bound Material Type</b>	32mm A/C <sup>1</sup>
<b>Thickness Found</b>	53
<b>4) Bound Material Type</b>	32mm A/C <sup>1</sup>
<b>Thickness Found (mm)</b>	90
<b>Foundation Material</b>	Granular subbase
<b>Significant Quantity Lifted</b>	No
<b>WAC Potentially Required</b>	Yes

**Remarks:** Tar present in 32mm A/C

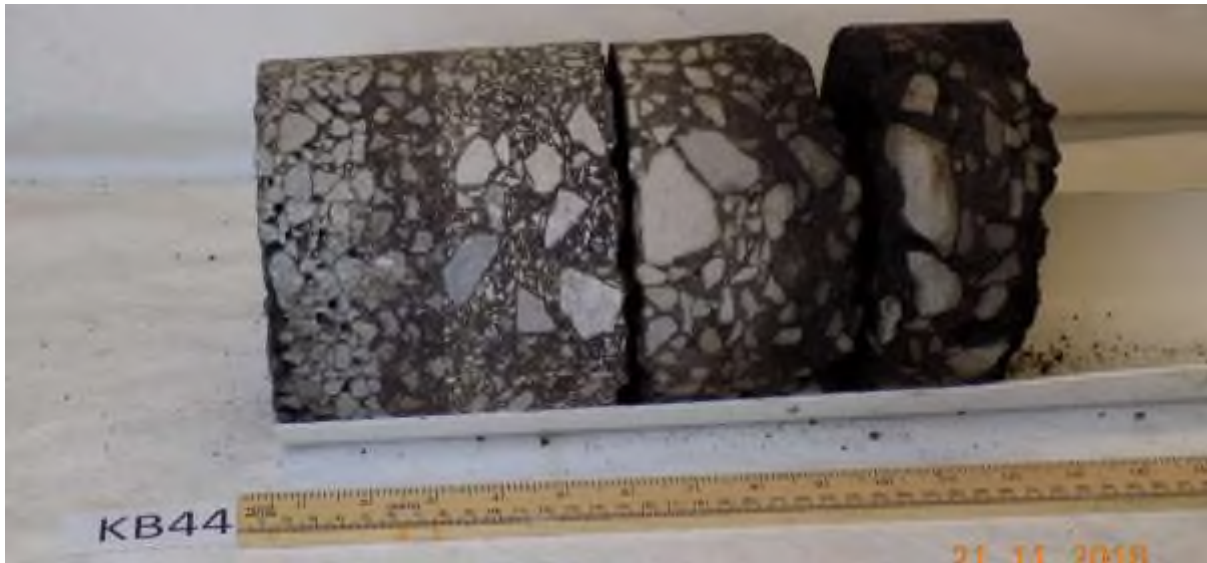
**2.44 Core reference: KB44**

**Plate 45:** Core reference: KB44**Table 45:** Visual examination results and WAC recommendations for core ref: KB44

<b>Core Reference:</b>	KB44
<b>Location</b>	Lane 1, westbound
<b>Total Depth Core (mm)</b>	297
<b>Surface Course Type</b>	14mm SMA <sup>1</sup>
<b>Aggregate Type &amp; PSV</b>	Gritstone 60
<b>Thickness Found (mm)</b>	43
<b>1) Bound Material Type</b>	14mm 35% HRA
<b>Thickness Found (mm)</b>	22
<b>2) Bound Material Type</b>	20mm A/C
<b>Thickness Found (mm)</b>	67
<b>3) Bound Material Type</b>	32mm A/C <sup>3,7</sup>
<b>Thickness Found</b>	90
<b>4) Bound Material Type</b>	32mm A/C <sup>3</sup>
<b>Thickness Found (mm)</b>	75
<b>Foundation Material</b>	Granular subbase
<b>Significant Quantity Lifted</b>	No
<b>WAC Potentially Required</b>	Yes

**Remarks:** Tar present in 32mm A/C
