[BNES Keynsham bypass Report 11367-2016.pdf](#)

North Somerset Council Highway Services Laboratory

REPORT No: 11/03-BCC-Wells Road Bristol-

**TEST : Visual Examination of Cores and Each layer chemically tested for Tar presence and those identified further tested for Waste Acceptance Criteria Certification**

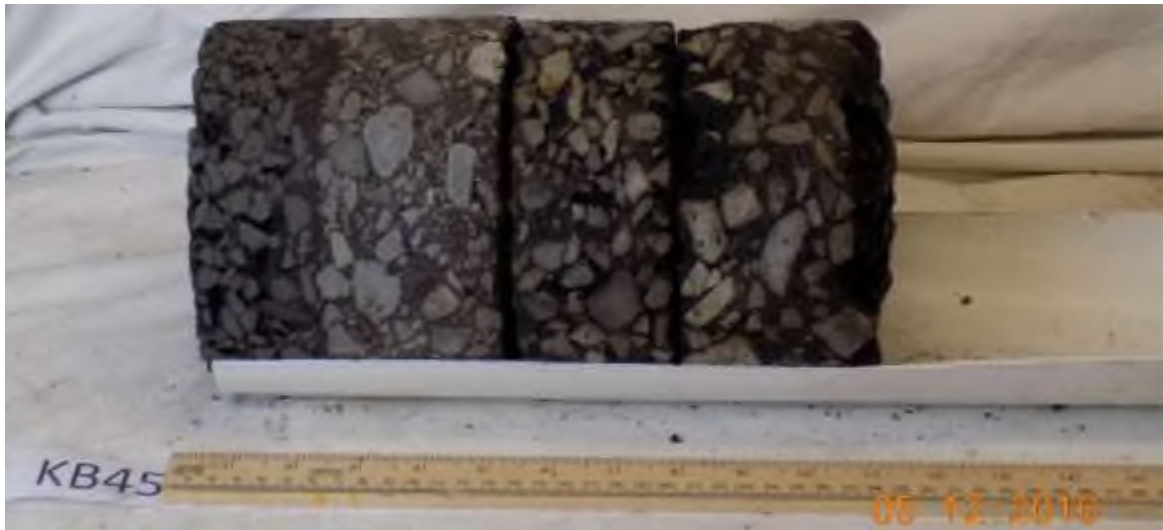
**2.45 Core reference: KB45**

**Plate 46:** Core reference: KB45**Table 46:** Visual examination results and WAC recommendations for core ref: KB45

<b>Core Reference:</b>	KB45
<b>Location</b>	Lane 2, westbound
<b>Total Depth Core (mm)</b>	253-261
<b>Surface Course Type</b>	14mm SMA <sup>1</sup>
<b>Aggregate Type &amp; PSV</b>	Gritstone 60
<b>Thickness Found (mm)</b>	45
<b>1) Bound Material Type</b>	14mm 35% HRA
<b>Thickness Found (mm)</b>	0-8
<b>2) Bound Material Type</b>	20mm A/C <sup>7</sup>
<b>Thickness Found (mm)</b>	68
<b>3) Bound Material Type</b>	20mm A/C <sup>7</sup>
<b>Thickness Found</b>	60
<b>4) Bound Material Type</b>	32mm A/C <sup>3</sup>
<b>Thickness Found (mm)</b>	80
<b>Foundation Material</b>	Granular subbase
<b>Significant Quantity Lifted</b>	No
<b>WAC Potentially Required</b>	Yes

**Remarks:** Tar present in 32mm A/C and some 20mm A/C

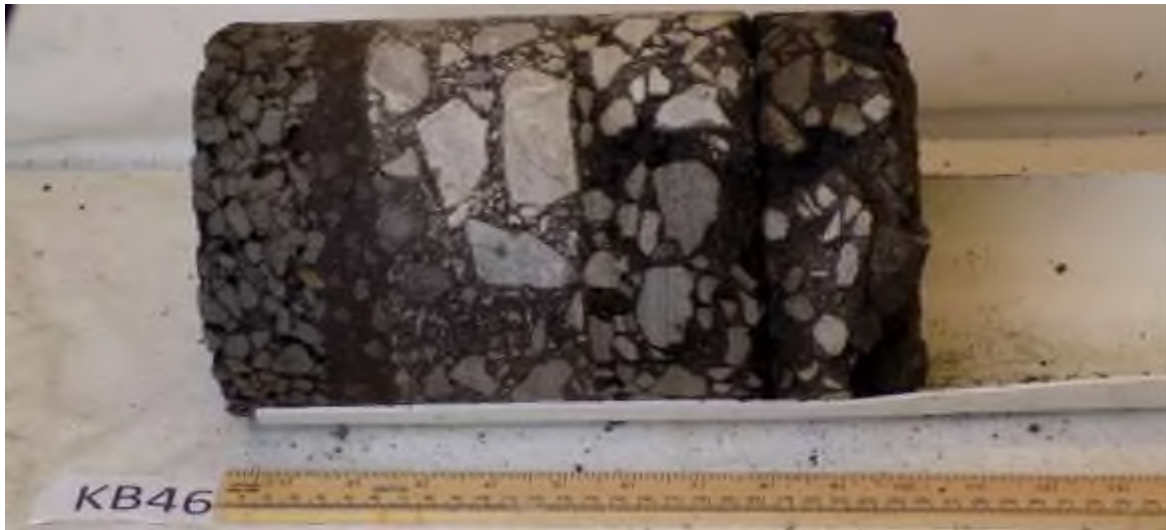
**2.46 Core reference: KB46**

**Plate 47:** Core reference: KB46**Table 47:** Visual examination results and WAC recommendations for core ref: KB46

<b>Core Reference:</b>	KB46
<b>Location</b>	Lane 1, westbound
<b>Total Depth Core (mm)</b>	266
<b>Surface Course Type</b>	14mm SMA <sup>1</sup>
<b>Aggregate Type &amp; PSV</b>	Gritstone 60
<b>Thickness Found (mm)</b>	45
<b>1) Bound Material Type</b>	14mm 35% HRA
<b>Thickness Found (mm)</b>	25
<b>2) Bound Material Type</b>	20mm A/C
<b>Thickness Found (mm)</b>	71
<b>3) Bound Material Type</b>	32mm A/C <sup>1,7</sup>
<b>Thickness Found</b>	62
<b>4) Bound Material Type</b>	32mm A/C <sup>10</sup>
<b>Thickness Found (mm)</b>	63
<b>Foundation Material</b>	Granular subbase
<b>Significant Quantity Lifted</b>	No
<b>WAC Potentially Required</b>	Yes

**Remarks:** Tar present in 32mm A/C

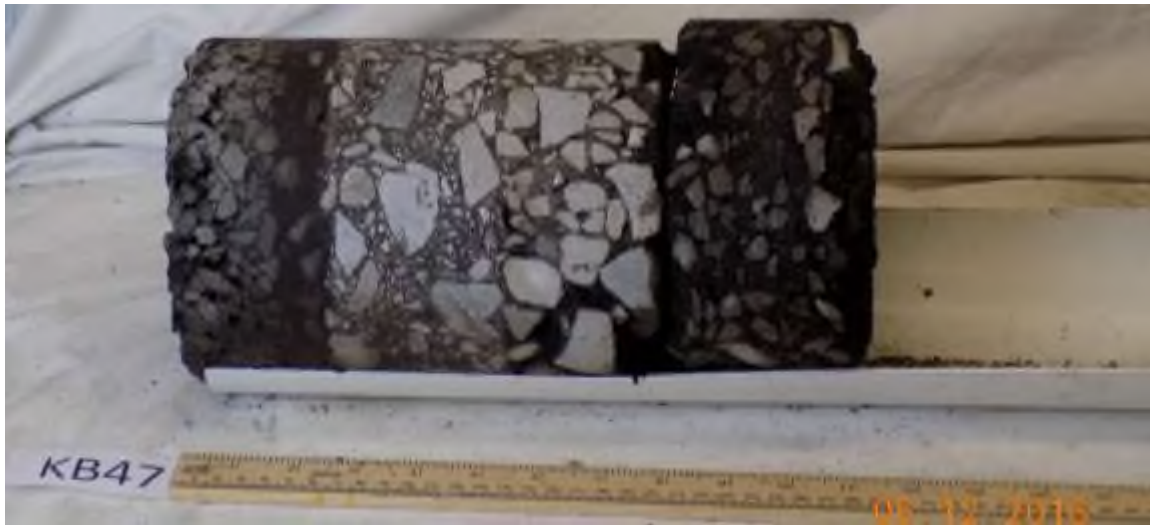
**2.47 Core reference: KB47**

**Plate 47:** Core reference: KB47**Table 47:** Visual examination results and WAC recommendations for core ref: KB47

<b>Core Reference:</b>	KB47
<b>Location</b>	Lane 2, westbound
<b>Total Depth Core (mm)</b>	275
<b>Surface Course Type</b>	14mm SMA <sup>1</sup>
<b>Aggregate Type &amp; PSV</b>	Gritstone 60
<b>Thickness Found (mm)</b>	41
<b>1) Bound Material Type</b>	14mm 35% HRA
<b>Thickness Found (mm)</b>	22
<b>2) Bound Material Type</b>	20mm A/C
<b>Thickness Found (mm)</b>	73
<b>3) Bound Material Type</b>	32mm A/C <sup>7,1</sup>
<b>Thickness Found</b>	61
<b>4) Bound Material Type</b>	32mm A/C
<b>Thickness Found (mm)</b>	78
<b>Foundation Material</b>	Granular subbase
<b>Significant Quantity Lifted</b>	No
<b>WAC Potentially Required</b>	Yes

**Remarks:** Tar present in some 32mm A/C

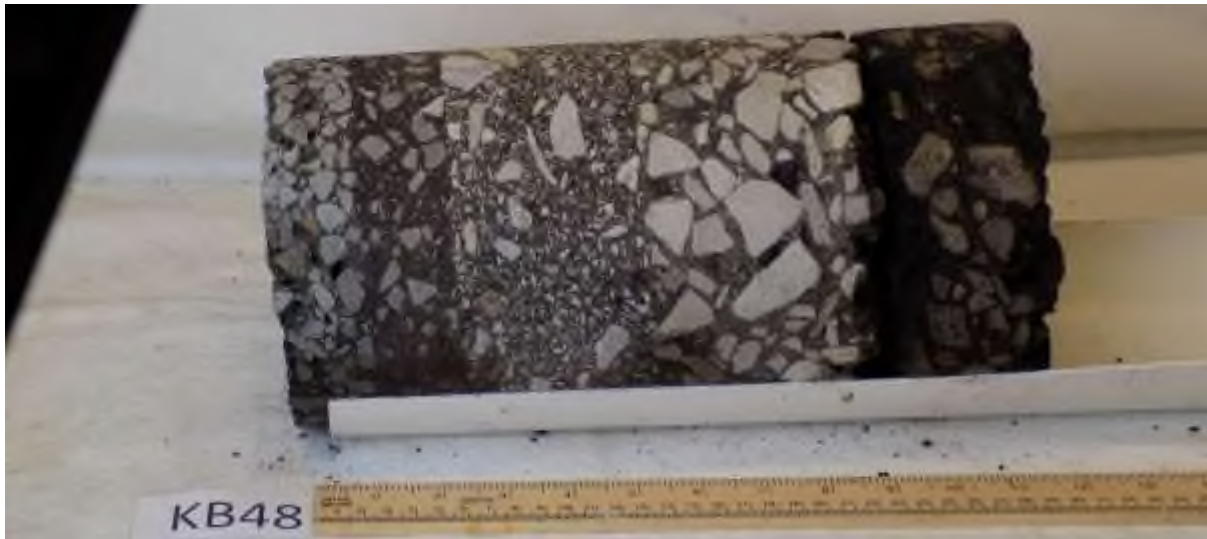
**2.48 Core reference: KB48**

**Plate 49:** Core reference: KB48**Table 49:** Visual examination result and WAC recommendations for core ref: KB48

<b>Core Reference:</b>	KB48
<b>Location</b>	Lane 1, westbound
<b>Total Depth Core (mm)</b>	298
<b>Surface Course Type</b>	14mm SMA <sup>1</sup>
<b>Aggregate Type &amp; PSV</b>	Gritstone 60
<b>Thickness Found (mm)</b>	34
<b>1) Bound Material Type</b>	14mm 35% HRA
<b>Thickness Found (mm)</b>	36
<b>2) Bound Material Type</b>	20mm A/C
<b>Thickness Found (mm)</b>	72
<b>3) Bound Material Type</b>	32mm A/C <sup>7,1</sup>
<b>Thickness Found</b>	88
<b>4) Bound Material Type</b>	32mm A/C <sup>3</sup>
<b>Thickness Found (mm)</b>	68
<b>Foundation Material</b>	Granular subbase
<b>Significant Quantity Lifted</b>	No
<b>WAC Potentially Required</b>	Yes

**Remarks:** Tar present in 32mm A/C

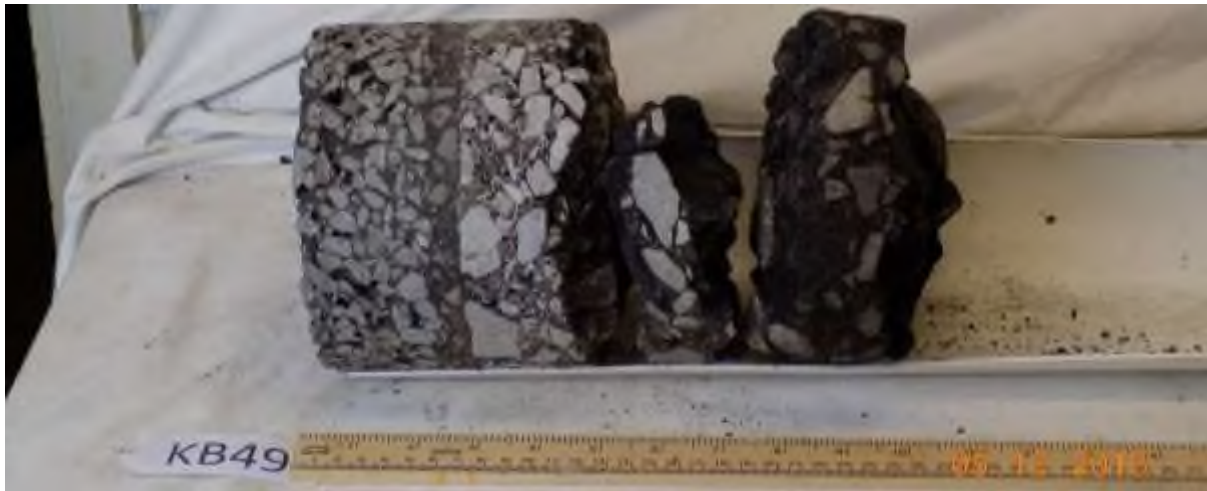
**2.49 Core reference: KB49**

**Plate 50:** Core reference: KB49**Table 50:** Visual examination results and WAC recommendations for core ref: KB49

<b>Core Reference:</b>	KB49
<b>Location</b>	Lane 2, westbound
<b>Total Depth Core (mm)</b>	276
<b>Surface Course Type</b>	14mm SMA <sup>1</sup>
<b>Aggregate Type &amp; PSV</b>	Gritstone 60
<b>Thickness Found (mm)</b>	54
<b>1) Bound Material Type</b>	14mm 35% HRA
<b>Thickness Found (mm)</b>	15
<b>2) Bound Material Type</b>	20mm A/C <sup>7</sup>
<b>Thickness Found (mm)</b>	55
<b>3) Bound Material Type</b>	32mm A/C <sup>3</sup>
<b>Thickness Found</b>	72
<b>4) Bound Material Type</b>	32mm A/C <sup>3</sup>
<b>Thickness Found (mm)</b>	80
<b>Foundation Material</b>	Granular subbase
<b>Significant Quantity Lifted</b>	No
<b>WAC Potentially Required</b>	Yes

**Remarks:** Tar present in 20mm and 32mm A/C

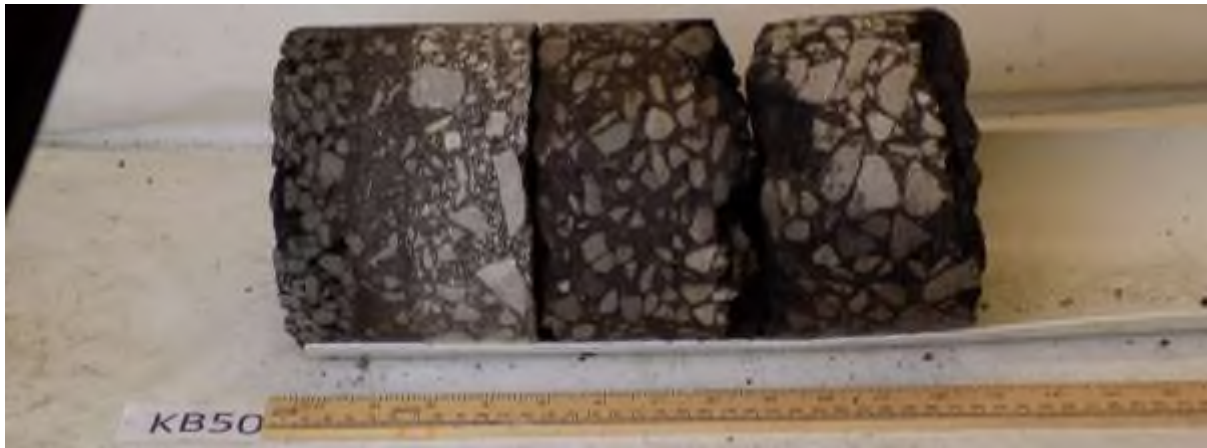
**2.50 Core reference: KB50**

**Plate 51:** Core reference: KB50**Table 51:** Visual examination results and WAC recommendations for core ref: KB50

<b>Core Reference:</b>	KB50
<b>Location</b>	Lane 1, westbound
<b>Total Depth Core (mm)</b>	288
<b>Surface Course Type</b>	14mm SMA <sup>1</sup>
<b>Aggregate Type &amp; PSV</b>	Gritstone 60
<b>Thickness Found (mm)</b>	30
<b>1) Bound Material Type</b>	14mm 35% HRA
<b>Thickness Found (mm)</b>	28
<b>2) Bound Material Type</b>	20mm A/C <sup>7</sup>
<b>Thickness Found (mm)</b>	53
<b>3) Bound Material Type</b>	32mm A/C <sup>3,7</sup>
<b>Thickness Found</b>	87
<b>4) Bound Material Type</b>	32mm A/C <sup>3</sup>
<b>Thickness Found (mm)</b>	90
<b>Foundation Material</b>	Granular subbase
<b>Significant Quantity Lifted</b>	No
<b>WAC Potentially Required</b>	Yes

**Remarks:** Tar present in 32mm A/C

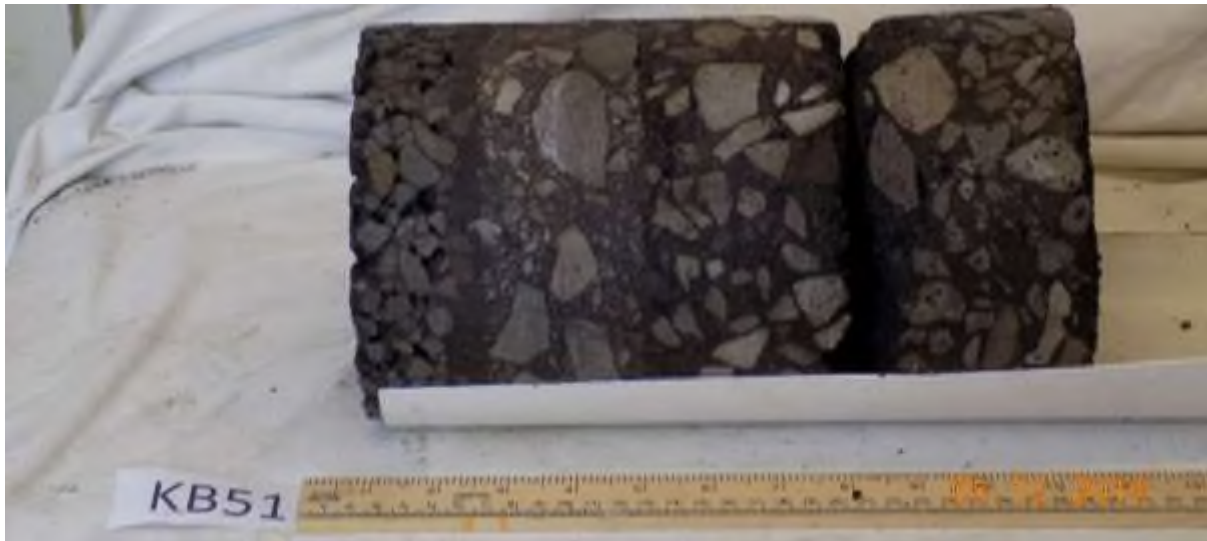
**2.51 Core reference: KB51**

**Plate 52:** Core reference: KB1**Table 52:** Visual examination results and WAC recommendations for core ref: KB1

<b>Core Reference:</b>	KB51
<b>Location</b>	Lane 2, westbound
<b>Total Depth Core (mm)</b>	258
<b>Surface Course Type</b>	14mm SMA <sup>1</sup>
<b>Aggregate Type &amp; PSV</b>	Gritstone 60
<b>Thickness Found (mm)</b>	33
<b>1) Bound Material Type</b>	14mm 35% HRA
<b>Thickness Found (mm)</b>	15
<b>2) Bound Material Type</b>	32mm A/C
<b>Thickness Found (mm)</b>	57
<b>3) Bound Material Type</b>	32mm A/C <sup>7</sup>
<b>Thickness Found</b>	73
<b>4) Bound Material Type</b>	32mm A/C
<b>Thickness Found (mm)</b>	80
<b>Foundation Material</b>	Concrete
<b>Significant Quantity Lifted</b>	No
<b>WAC Potentially Required</b>	Yes

**Remarks:** Tar present in 32mm A/C

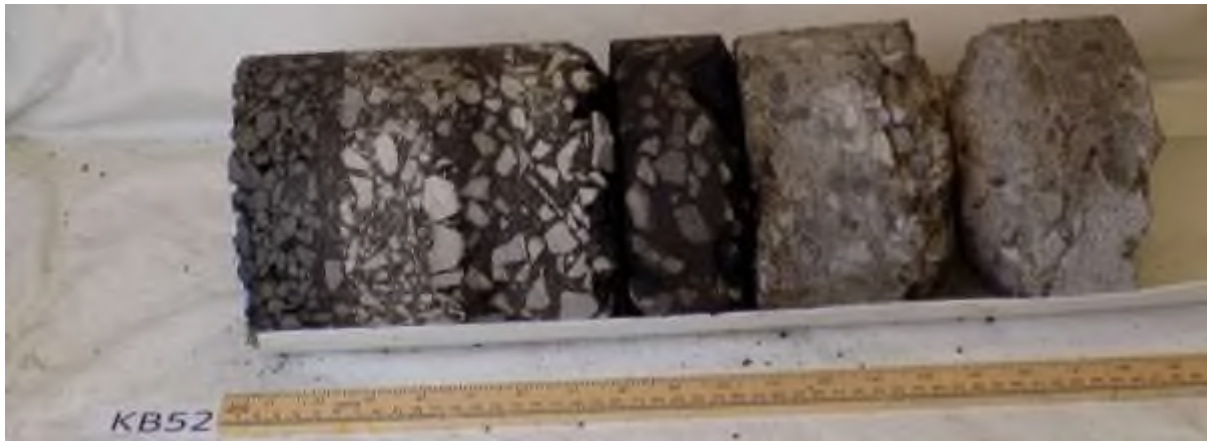
**2.52 Core reference: KB52**

**Plate 53:** Core reference: KB52**Table 53:** Visual examination results and WAC recommendations for core ref: KB52

<b>Core Reference:</b>	KB52
<b>Location</b>	Lane 1, westbound
<b>Total Depth Core (mm)</b>	426
<b>Surface Course Type</b>	14mm SMA <sup>1</sup>
<b>Aggregate Type &amp; PSV</b>	Gritstone 60
<b>Thickness Found (mm)</b>	40
<b>1) Bound Material Type</b>	14mm 35% HRA
<b>Thickness Found (mm)</b>	10
<b>2) Bound Material Type</b>	20mm A/C
<b>Thickness Found (mm)</b>	48
<b>3) Bound Material Type</b>	32mm A/C <sup>7</sup>
<b>Thickness Found</b>	73
<b>4) Bound Material Type</b>	32mm A/C <sup>7</sup>
<b>Thickness Found (mm)</b>	60
<b>5) Bound Material Type</b>	Concrete
<b>Thickness Found (mm)</b>	105
<b>6) Bound Material Type</b>	Concrete
<b>Thickness Found (mm)</b>	90
<b>Foundation Material</b>	Concrete
<b>Significant Quantity Lifted</b>	No
<b>WAC Potentially Required</b>	Yes

**Remarks:** Tar present in 32mm A/C

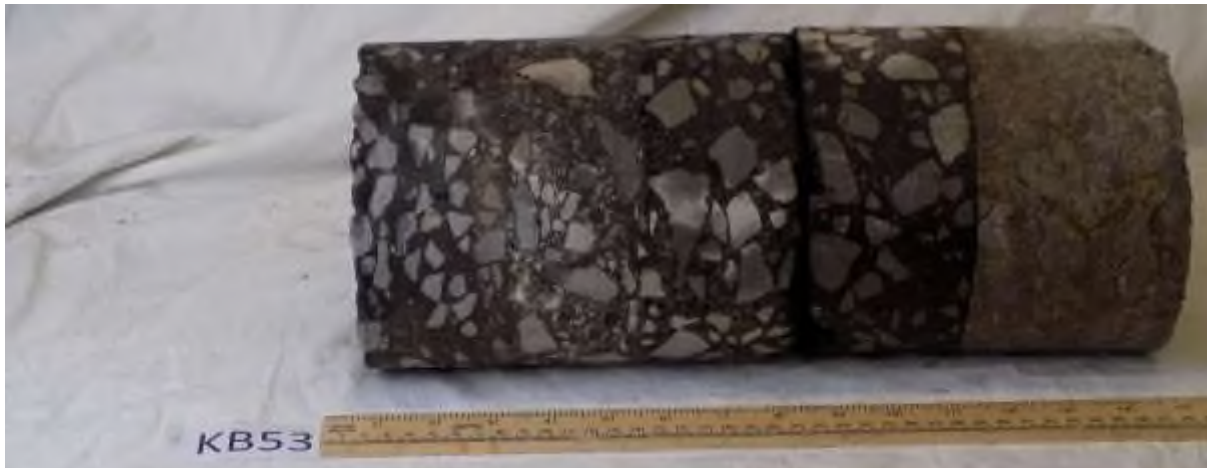
**2.53 Core reference: KB53**

**Plate 54:** Core reference: KB53**Table 54:** Visual examination results and WAC recommendations for core ref: KB53

<b>Core Reference:</b>	KB53
<b>Location</b>	Lane 2, westbound
<b>Total Depth Core (mm)</b>	360
<b>Surface Course Type</b>	14mm 35% HRA
<b>Aggregate Type &amp; PSV</b>	Gritstone 60
<b>Thickness Found (mm)</b>	53
<b>1) Bound Material Type</b>	14mm A/C
<b>Thickness Found (mm)</b>	17
<b>2) Bound Material Type</b>	32mm A/C
<b>Thickness Found (mm)</b>	55
<b>3) Bound Material Type</b>	32mm A/C <sup>7</sup>
<b>Thickness Found</b>	71
<b>4) Bound Material Type</b>	32mm A/C
<b>Thickness Found (mm)</b>	71
<b>5) Bound Material Type</b>	Concrete
<b>Thickness Found (mm)</b>	93
<b>Foundation Material</b>	Concrete
<b>Significant Quantity Lifted</b>	No
<b>WAC Potentially Required</b>	Yes

**Remarks:** Tar present in 32mm A/C

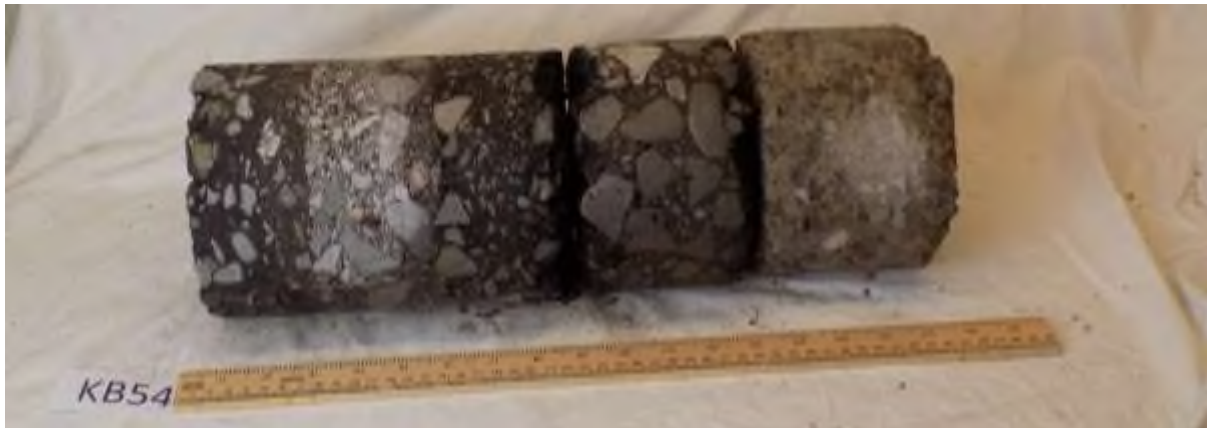
**2.54 Core reference: KB54**

**Plate 55:** Core reference: KB54**Table 55:** Visual examination results and WAC recommendations for core ref: KB54

<b>Core Reference:</b>	KB54
<b>Location</b>	Lane 1
<b>Total Depth Core (mm)</b>	413
<b>Surface Course Type</b>	14mm 35% HRA
<b>Aggregate Type &amp; PSV</b>	Gritstone 60
<b>Thickness Found (mm)</b>	40
<b>1) Bound Material Type</b>	14mm 35% HRA
<b>Thickness Found (mm)</b>	26
<b>2) Bound Material Type</b>	28mm A/C
<b>Thickness Found (mm)</b>	68
<b>3) Bound Material Type</b>	32mm A/C
<b>Thickness Found</b>	75
<b>4) Bound Material Type</b>	32mm A/C
<b>Thickness Found (mm)</b>	92
<b>5) Bound Material Type</b>	Concrete
<b>Thickness Found (mm)</b>	112
<b>Foundation Material</b>	Concrete
<b>Significant Quantity Lifted</b>	No
<b>WAC Potentially Required</b>	Yes

**Remarks:** Tar present in 32mm A/C

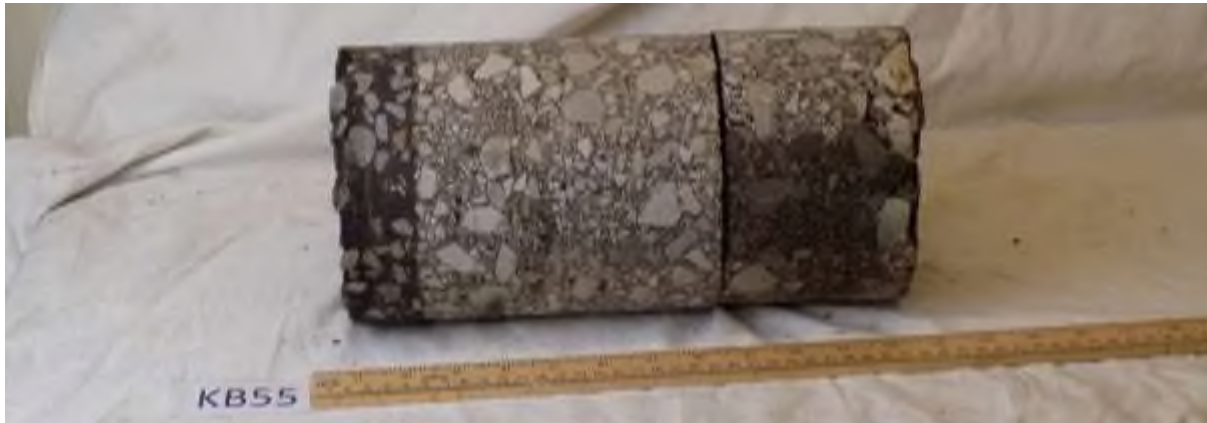
**2.55 Core reference: KB55**

**Plate 56:** Core reference: KB55**Table 56:** Visual examination results and WAC recommendations for core ref: KB55

<b>Core Reference:</b>	KB55
<b>Location</b>	Lane 2, westbound
<b>Total Depth Core (mm)</b>	316
<b>Surface Course Type</b>	14mm 35% HRA
<b>Aggregate Type &amp; PSV</b>	Gritstone 60
<b>Thickness Found (mm)</b>	43
<b>1) Bound Material Type</b>	20mm A/C
<b>Thickness Found (mm)</b>	78
<b>2) Bound Material Type</b>	32mm A/C
<b>Thickness Found (mm)</b>	93
<b>3) Bound Material Type</b>	32mm A/C
<b>Thickness Found</b>	102
<b>Foundation Material</b>	Concrete
<b>Significant Quantity Lifted</b>	No
<b>WAC Potentially Required</b>	No

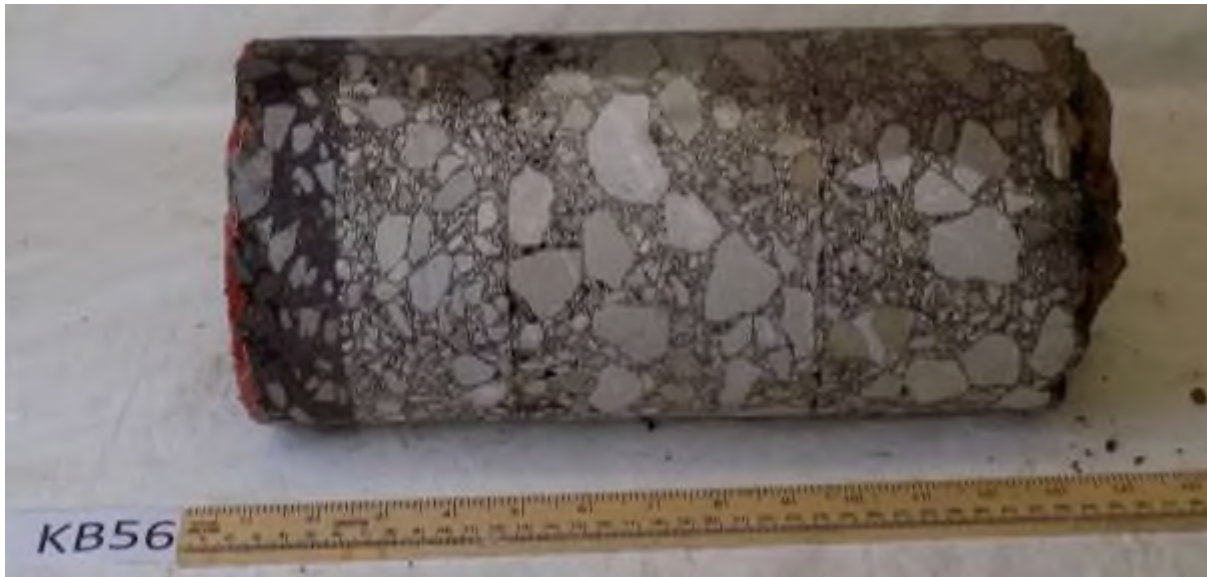
**2.56 Core reference: KB56**

**Plate 57:** Core reference: KB56**Table 57:** Visual examination results and WAC recommendation for core ref: KB56

<b>Core Reference:</b>	KB56
<b>Location</b>	Lane 1, westbound
<b>Total Depth Core (mm)</b>	314
<b>Surface Course Type</b>	Red high friction surfacing
<b>Aggregate Type &amp; PSV</b>	Calcined bauxite 68
<b>Thickness Found (mm)</b>	3
<b>1) Bound Material Type</b>	14mm HRA
<b>Thickness Found (mm)</b>	38
<b>2) Bound Material Type</b>	20mm A/C
<b>Thickness Found (mm)</b>	63
<b>3) Bound Material Type</b>	32mm A/C
<b>Thickness Found</b>	112
<b>4) Bound Material Type</b>	32mm A/C
<b>Thickness Found (mm)</b>	98
<b>Foundation Material</b>	Granular subbase
<b>Significant Quantity Lifted</b>	No
<b>WAC Potentially Required</b>	No

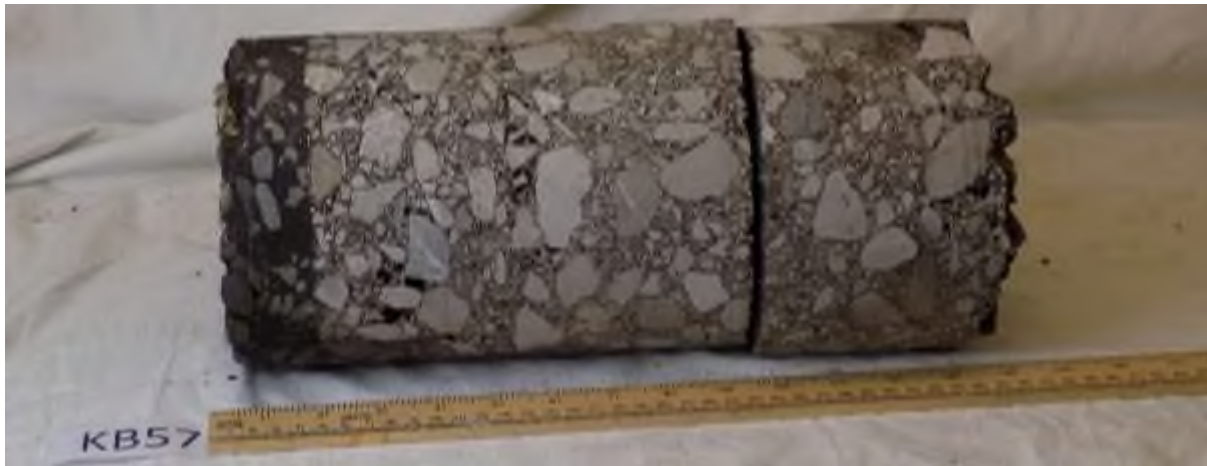
**2.57 Core reference: KB57**

**Plate 58:** Core reference: KB57**Table 58:** Visual examination results and WAC recommendations for core ref: KB57

<b>Core Reference:</b>	KB57
<b>Location</b>	Lane 2, westbound
<b>Total Depth Core (mm)</b>	338
<b>Surface Course Type</b>	14mm 35% HRA
<b>Aggregate Type &amp; PSV</b>	Gritstone 60
<b>Thickness Found (mm)</b>	39
<b>1) Bound Material Type</b>	20mm A/C
<b>Thickness Found (mm)</b>	88
<b>2) Bound Material Type</b>	32mm A/C <sup>7</sup>
<b>Thickness Found (mm)</b>	103
<b>3) Bound Material Type</b>	32mm A/C
<b>Thickness Found</b>	108
<b>Foundation Material</b>	Granular subbase
<b>Significant Quantity Lifted</b>	No
<b>WAC Potentially Required</b>	No

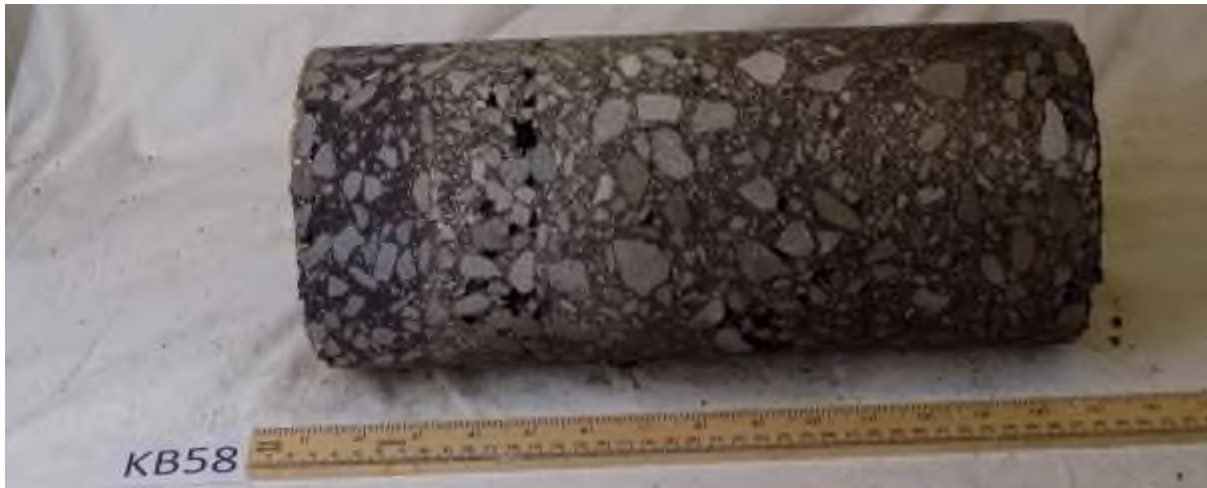
**2.58 Core reference: KB58**

**Plate 59:** Core reference: KB58**Table 59:** Visual examination results and WAC recommendations for core ref: KB58

<b>Core Reference:</b>	KB58
<b>Location</b>	Lane 1, westbound
<b>Total Depth Core (mm)</b>	339
<b>Surface Course Type</b>	14mm 35% HRA
<b>Aggregate Type &amp; PSV</b>	Gritstone 60
<b>Thickness Found (mm)</b>	53
<b>1) Bound Material Type</b>	20mm A/C <sup>1</sup>
<b>Thickness Found (mm)</b>	52
<b>2) Bound Material Type</b>	32mm A/C
<b>Thickness Found (mm)</b>	234
<b>Foundation Material</b>	Granular subbase
<b>Significant Quantity Lifted</b>	No
<b>WAC Potentially Required</b>	No
