## Resurfacing Requirements

The table below shows the history of the carriageway treatments of each site and the proposed requirements.

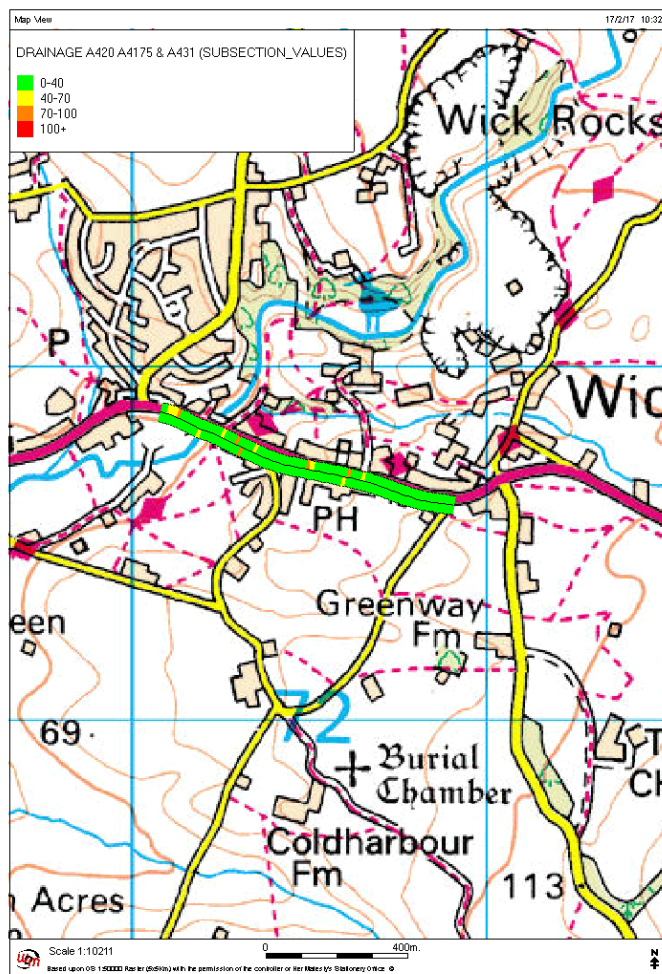
## A420 High Street Wick

Resurfaced in 2011 (50mm thick HRA). Proposed surface dressing programme in 5-7 years time.

No action required at current time.

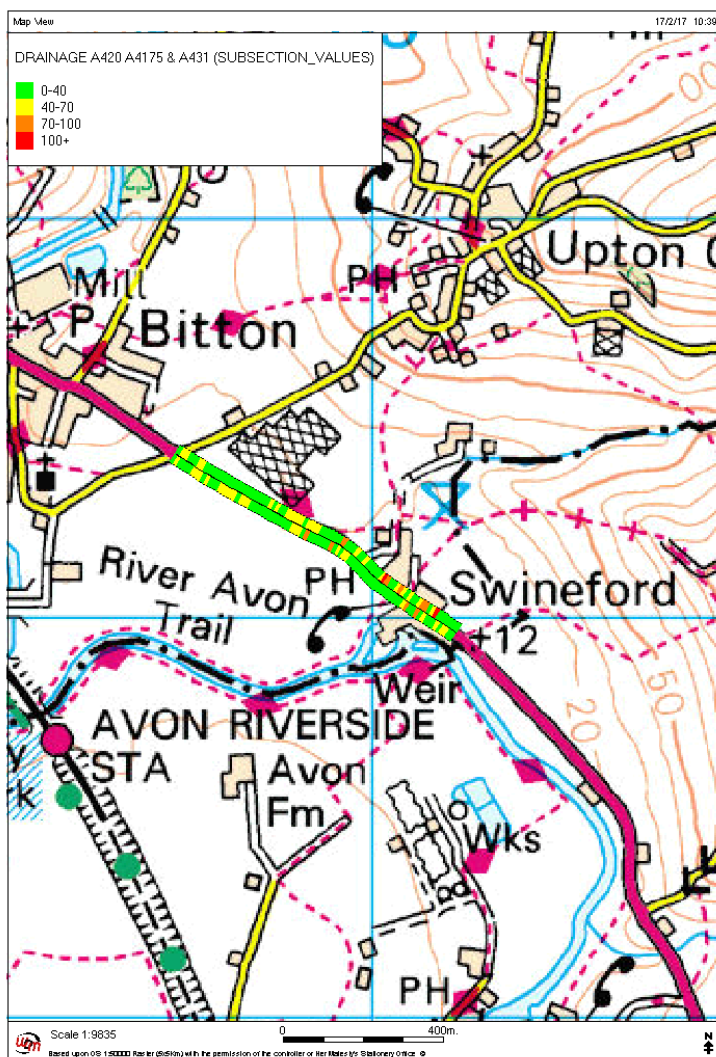
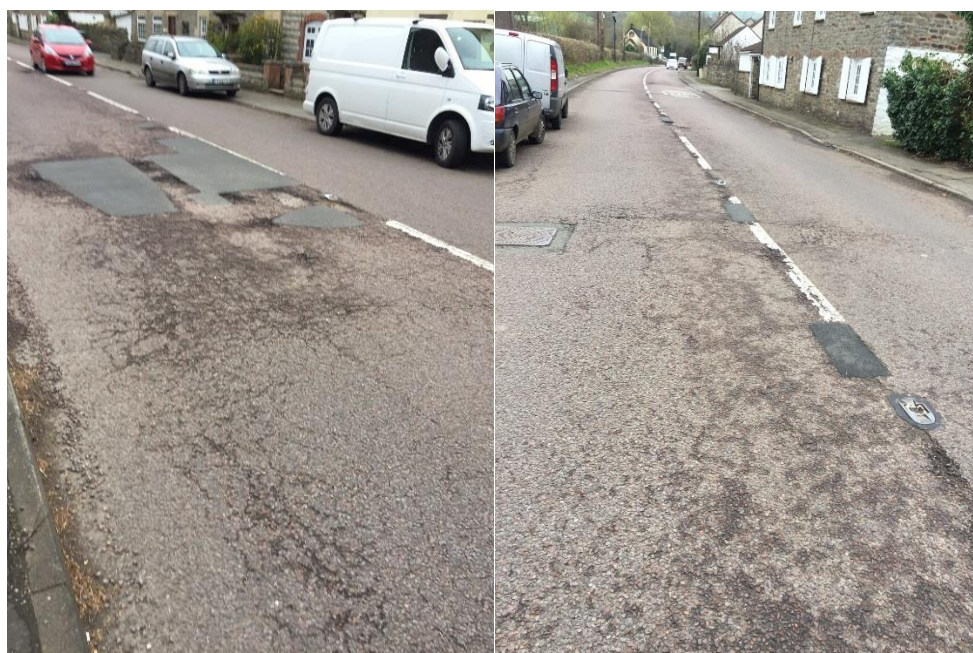
Poor surface course and will need to be resurfaced within two years.

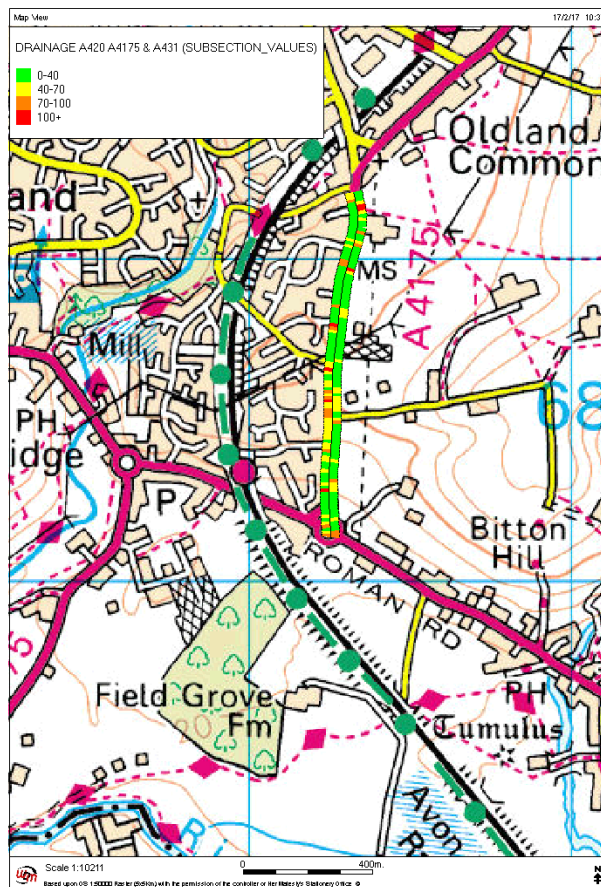
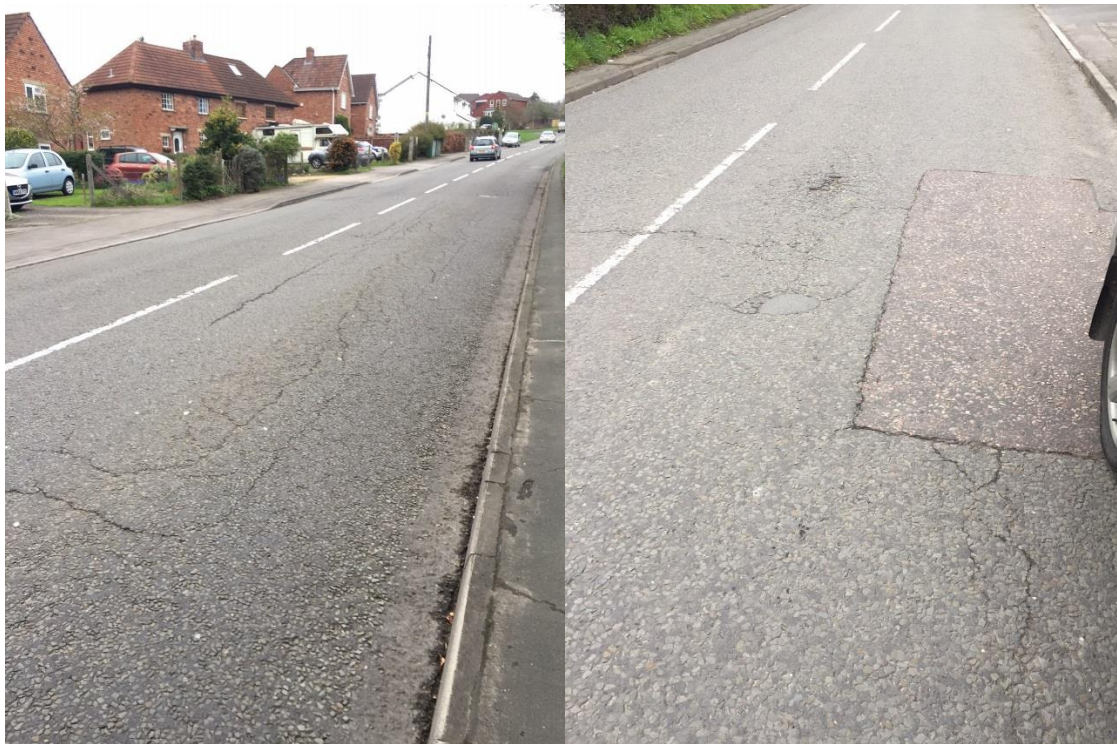
## A4175 Cherry Garden Road

Satisfactory HRA surface course showing signs of deterioration. Some limited patching can be carried out in 2017 for a surface dressing site in 2018.

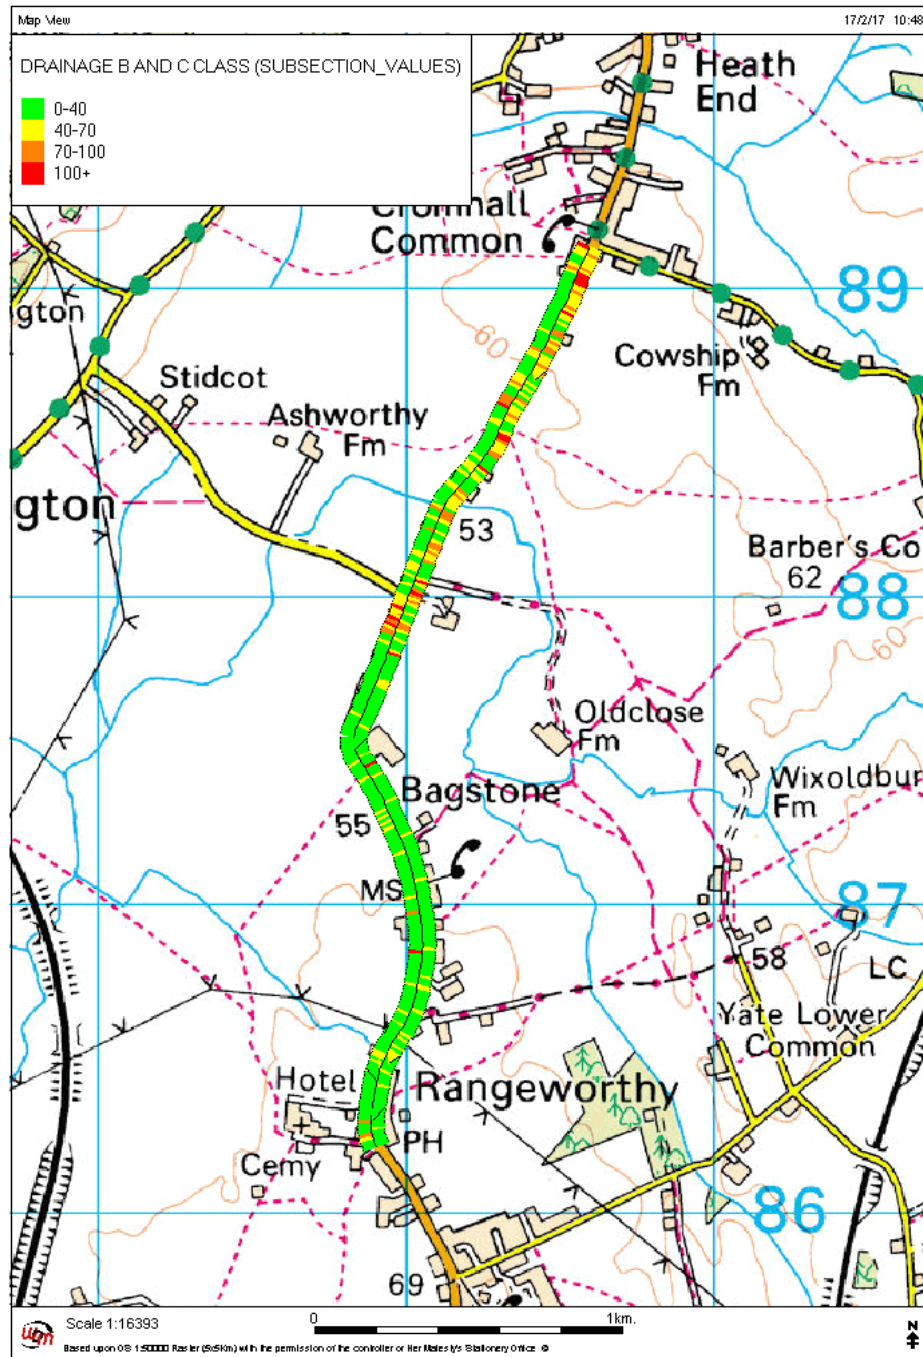
## B4058 Bagstone Road

Surface Dressed in 2011 and is in satisfactory condition. There is some fattening up in certain areas and surveys show a low texture reading. A hydro-retexture treatment would resolve the low texture issues.

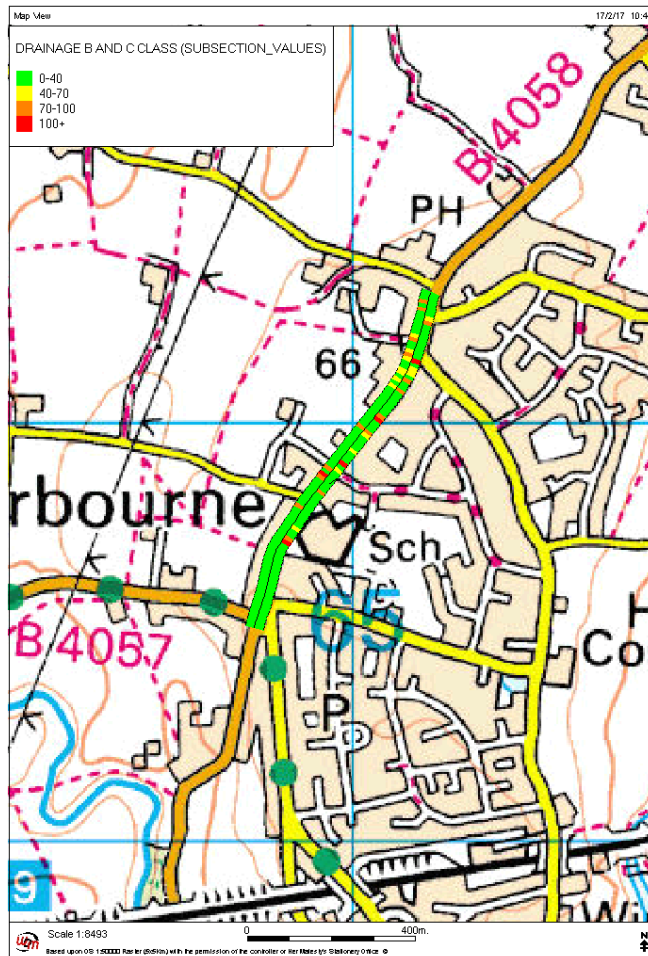
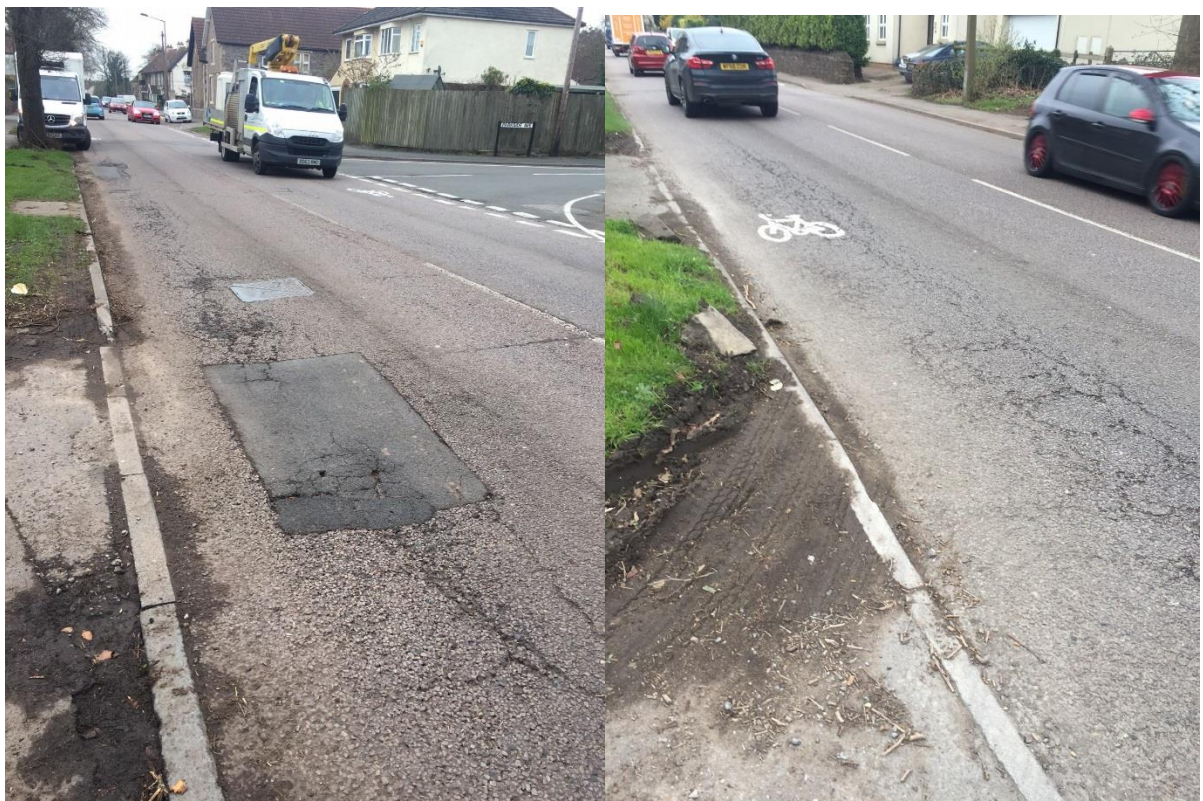
## 4058 High Street Winterbourne

Resurfaced in 2005 and showing signs of significant structural failures in certain areas. The road will need to be resurfaced in 1 to 2 years time which will incorporate some reconstruction.

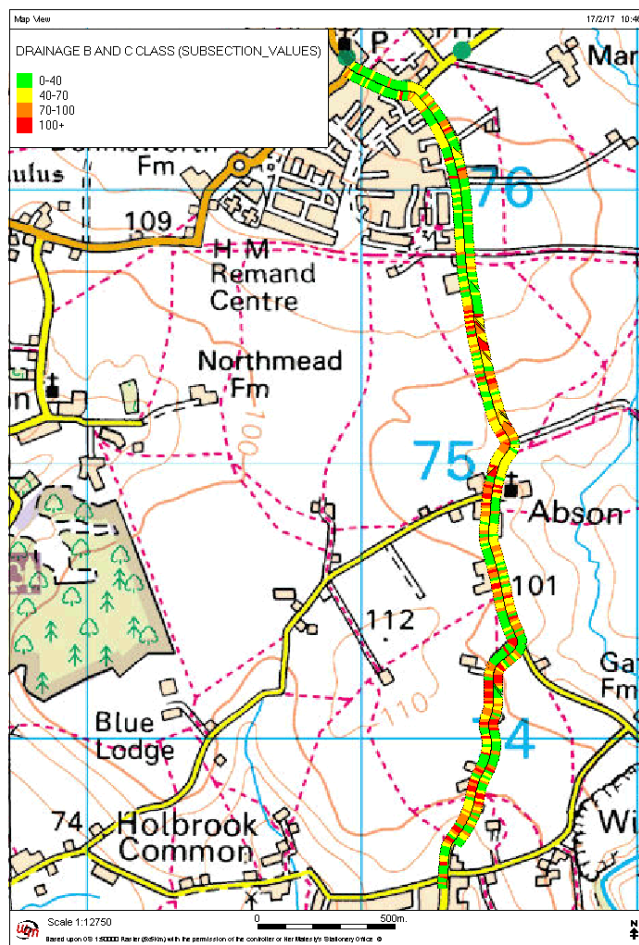
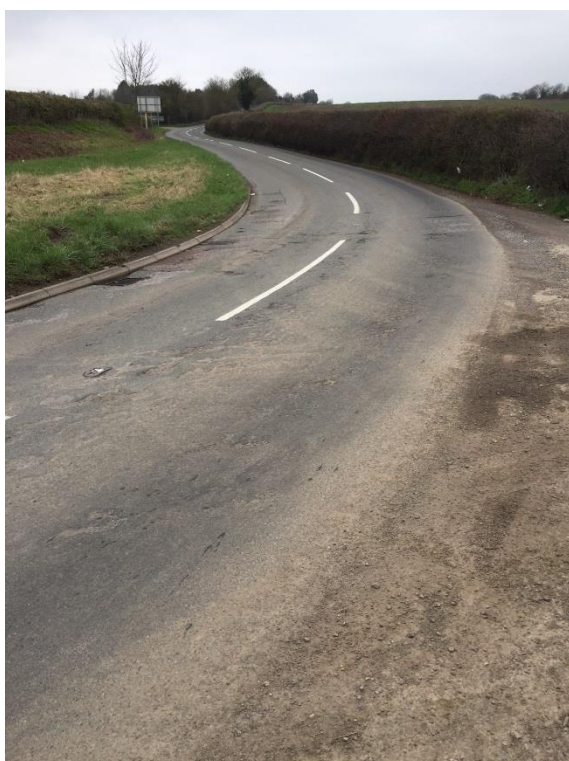
## Abson Road, Wick/Pucklechurch

Abson Road is scheduled to be surface dressed within the next 2-3 years. This will include preparation (pre patching) work. SGC will incorporate the dressing in the 2018 capital programme.

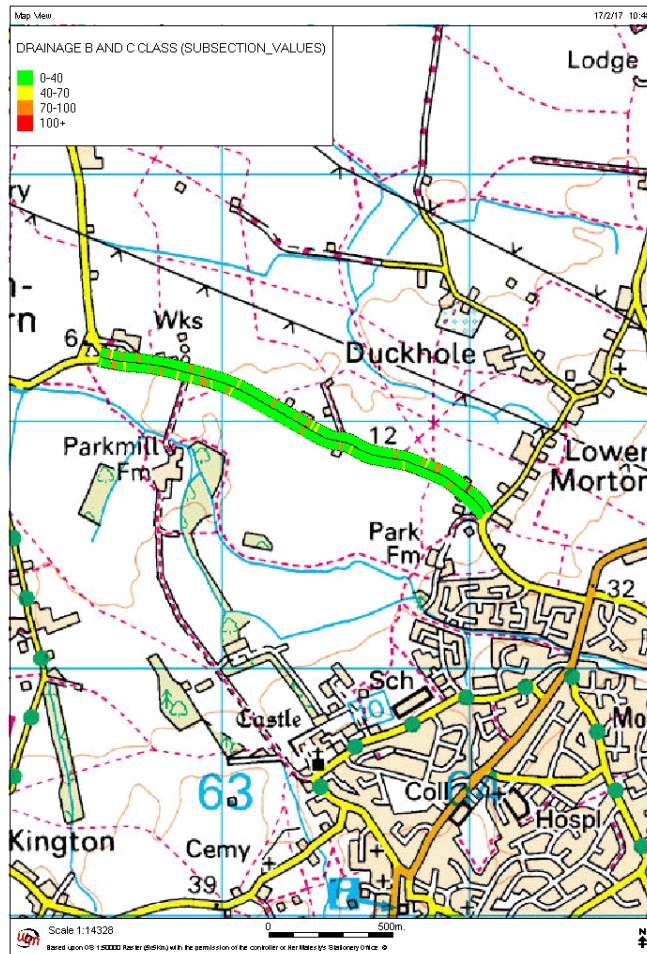
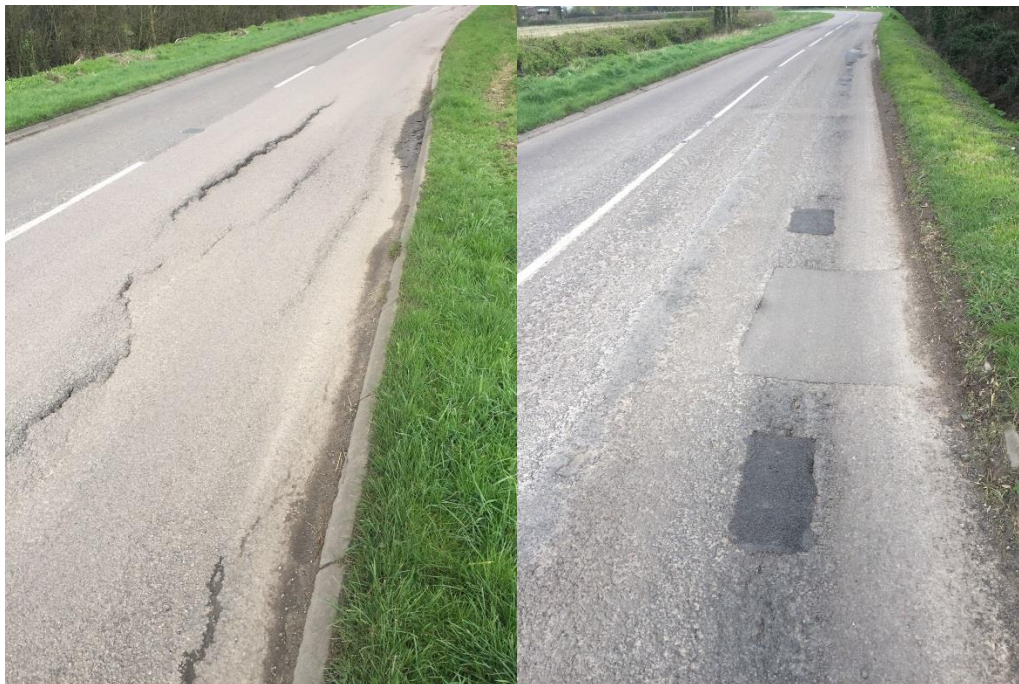
## Oldbury Lane, Oldbury

Oldbury lane is in need of surface dressing within 1-2 years. There are significant structural issues along certain lengths of this road. SGC will incorporate the dressing in the 2018 capital programme.

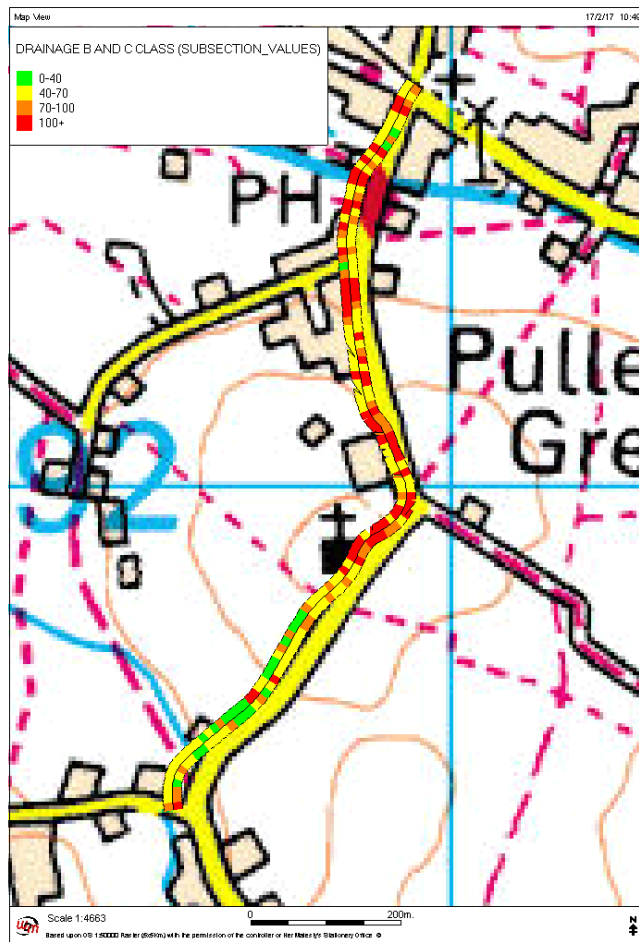
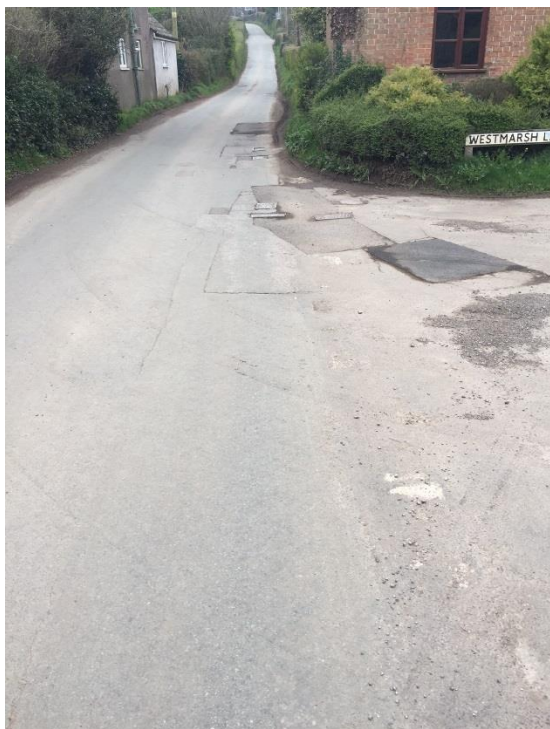
## Church Lane, Oldbury

This site was surface dressed in 2010. It will need re-dressing in 3-4 years time. No action required at this time.

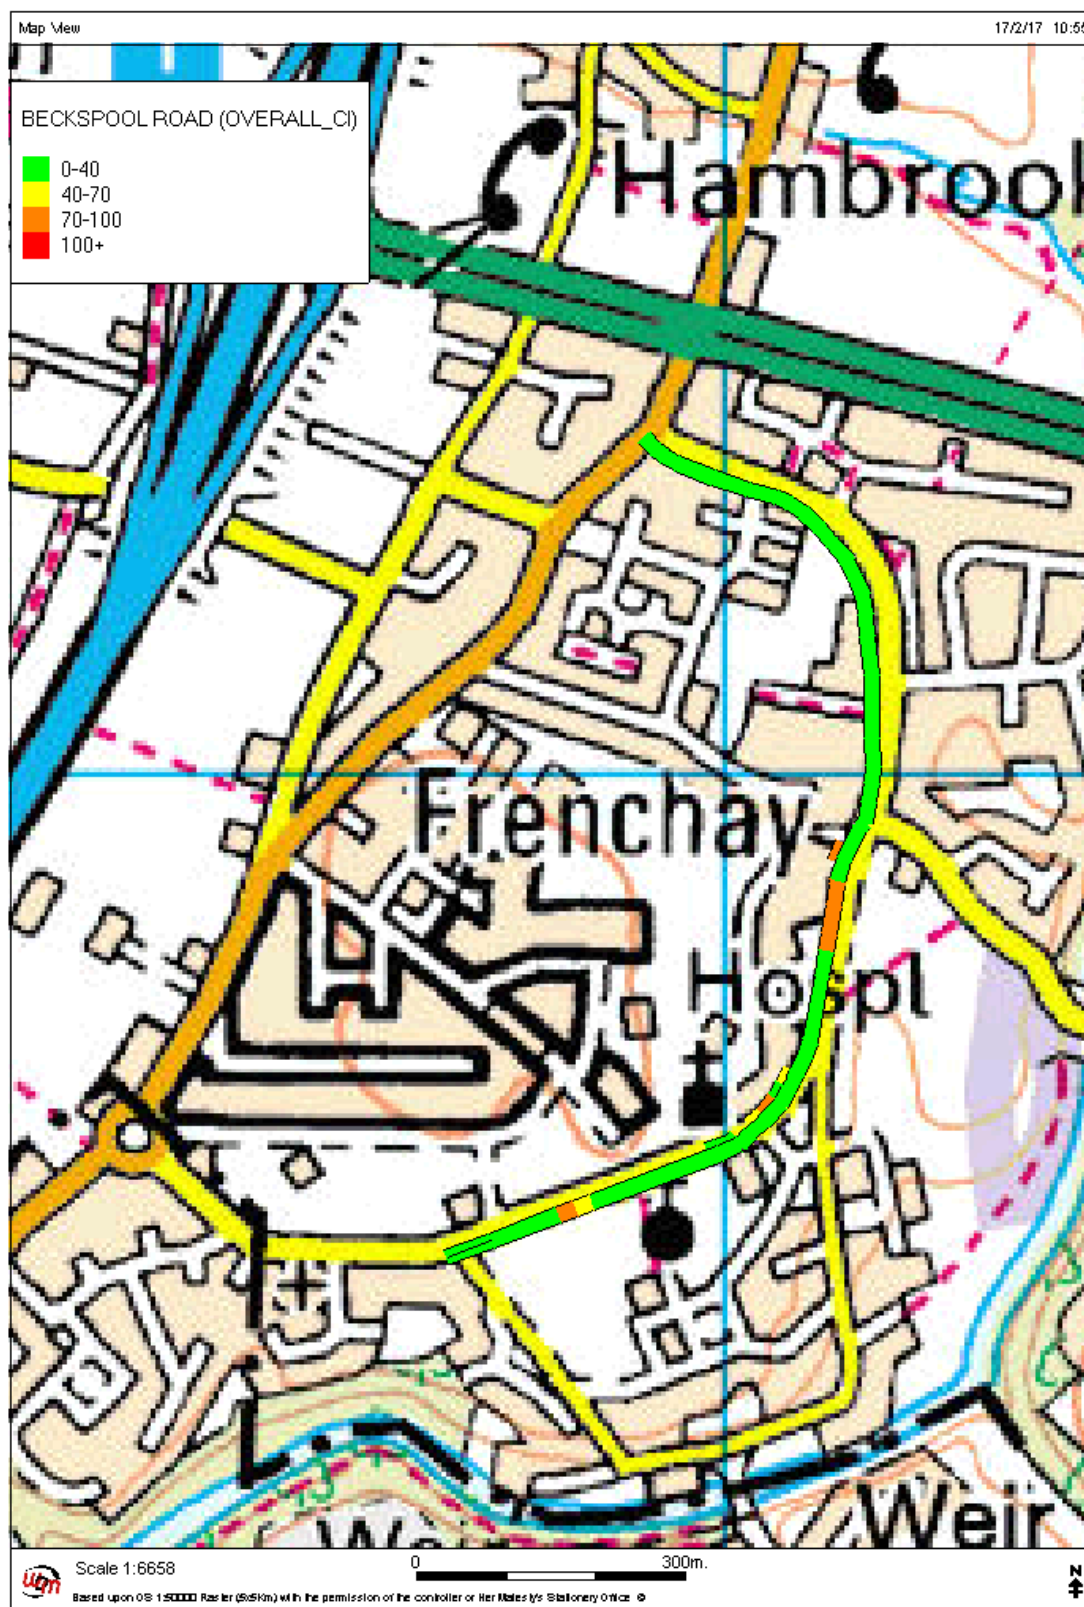
## Beckspool Road, Frenchay

This site was surfaced (SMA 40mm thick) in 2011. No action required at this time.
